BEAVER BROOK RESTORATION PLAN

STREAM MORPHOLOGY, WILDLIFE HABITAT, AND LAND USE ASSESSMENT

KEENE, NEW HAMPSHIRE

May 2009

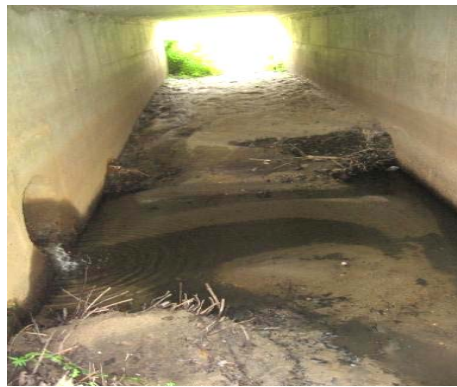
Marlboro Bridge Crossing

At the outfall of the storm drain pipes (Exhibit 27), there was significant build-up of sediment that has created sediment dams and allow water to pool upstream. This condition is called shoaling, and in some cases appears to be exacerbated by other obstructions in the stream.

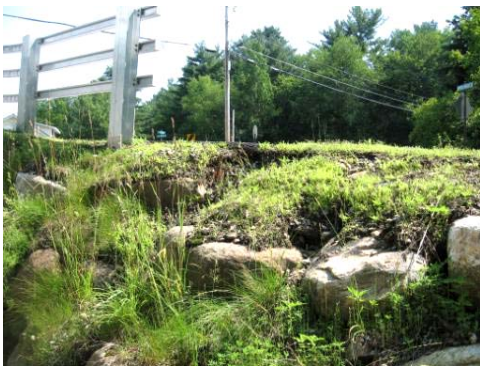
Upper Knight Street

An additional contribution of sediment to the shoaling of waters along the brook could be occurring due to deterioration of road and bridge shoulders that cross, or run parallel to, the stream. Depending on the bank vegetation structure and soil type, such diversion of road-water over a bank can quickly begin to cut and erode the material.

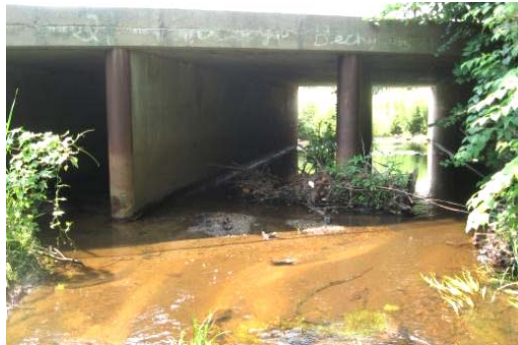
Baker Street Crossing

The build-up of sediment shoals result in ponded water, which in turns reduces stream aeration. In addition, during summer months, as the water crosses these shoals the flow is quite shallow. This shallow water, if not shaded, will quickly heat, thus reducing its ability to hold oxygen. Also such shallow flows can limit movement of aquatic species along the brook.

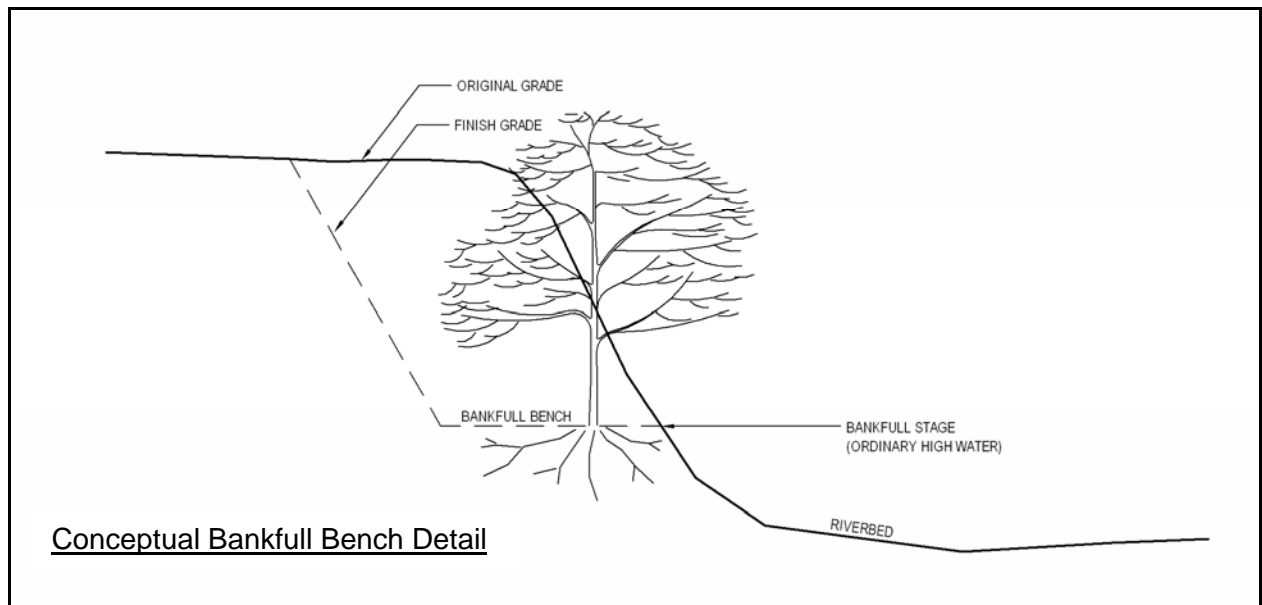
This segment, located just above the confluence with The Branch, appears to be the only segment in reach 1 which has not been straightened. The channel is sinuous with alternating riffle-pool bed features. The brook cuts through the higher floodplain of The Branch and riparian areas are, for the most part, well-vegetated and dominated by silver maple, a desirable native species for riparian areas and floodplains. Active erosion is occurring on the outside of the meander bends due to the height of these banks, which are well above the bankfull stage, and the relatively shallow rooting depths. Small active floodplains have formed on the inside of the meander bends, which are desirable features that can help store floodwaters.

Stabilization of bank segment R5, which is vegetated primarily with multiflora rose, is recommended by excavating a bankfull bench (see Conceptual Bankfull Bench Detail below) and planting the bench with native trees, shrubs, and herbs. Bank revetments and/or flow deflectors constructed of logs, root fans, and large stone could also be installed to protect the bank while vegetation becomes established and to provide in-stream structure. The other eroding banks in this segment could be stabilized in a similar manner; however, this would require removing existing trees and understory vegetation which is not recommended.
