GOOSE POND MASTER PLAN STUDY

Prepared for

The Conservation Commission
Keene, New Hampshire

November 1984

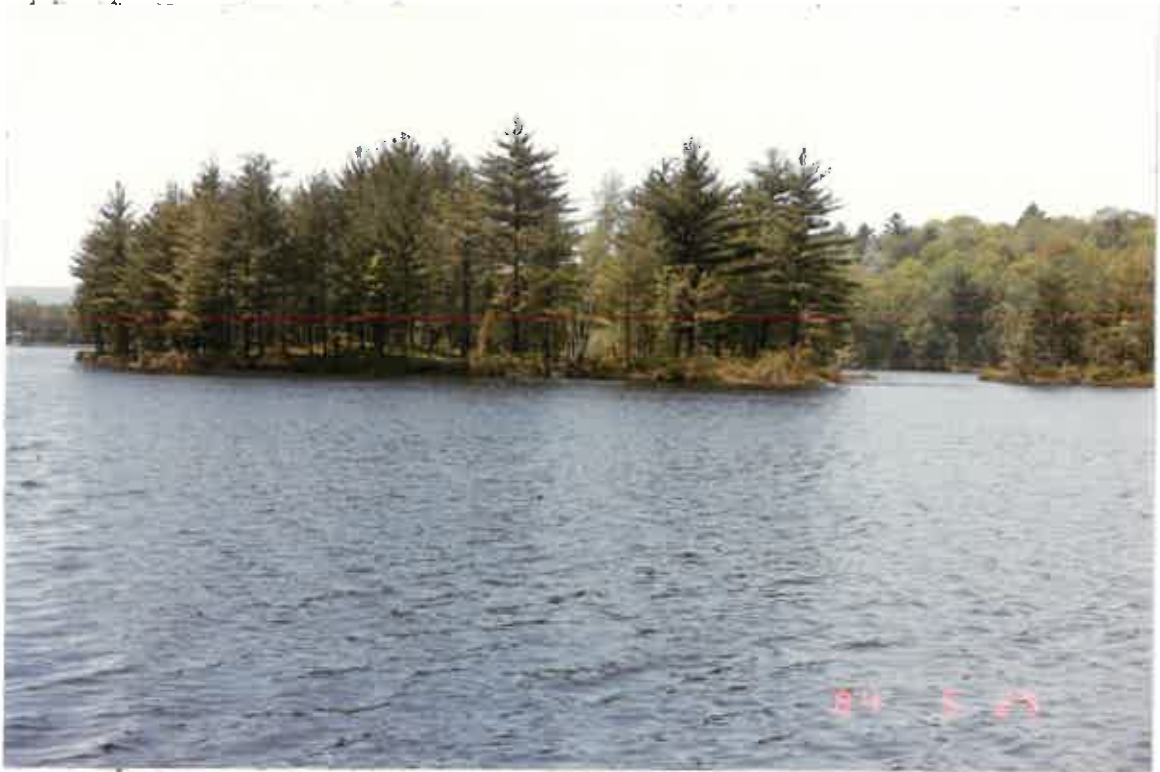
Photo 1. The island in Goose Pond, its most notable feature.

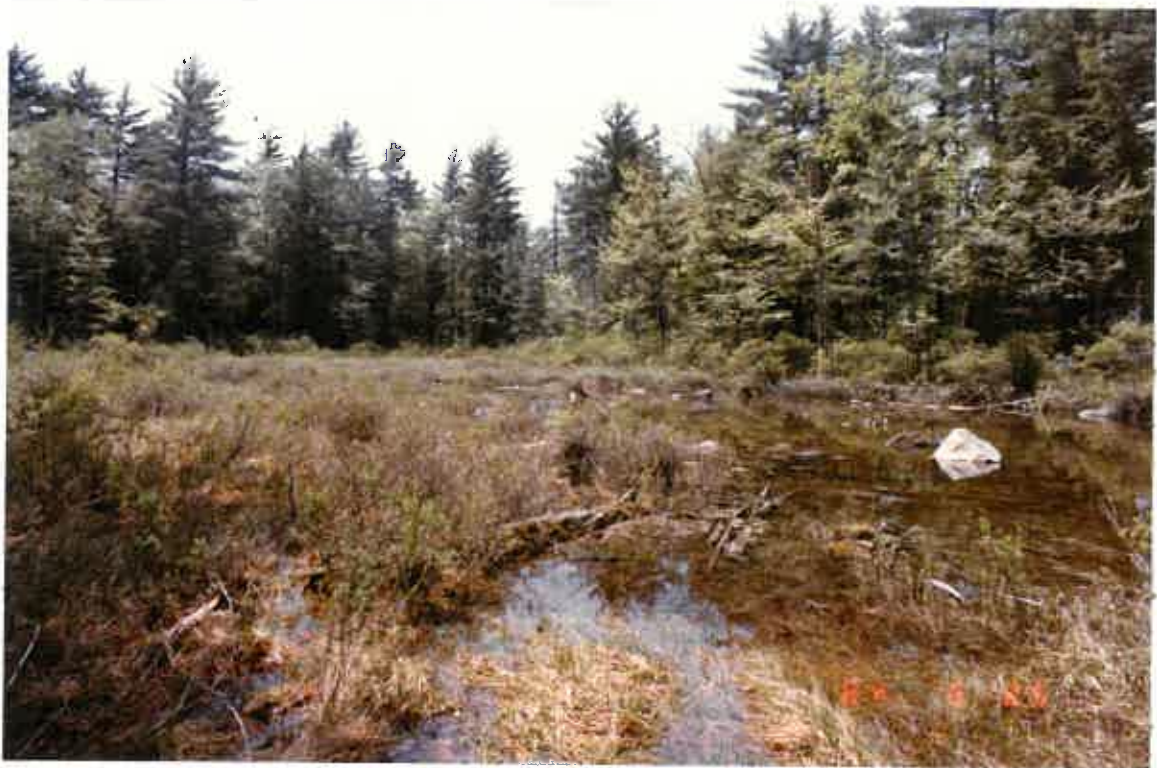
Photo 2. Ericaceous bog association at southeast margin of Goose Pond. Area is rich in both plant and animal life.

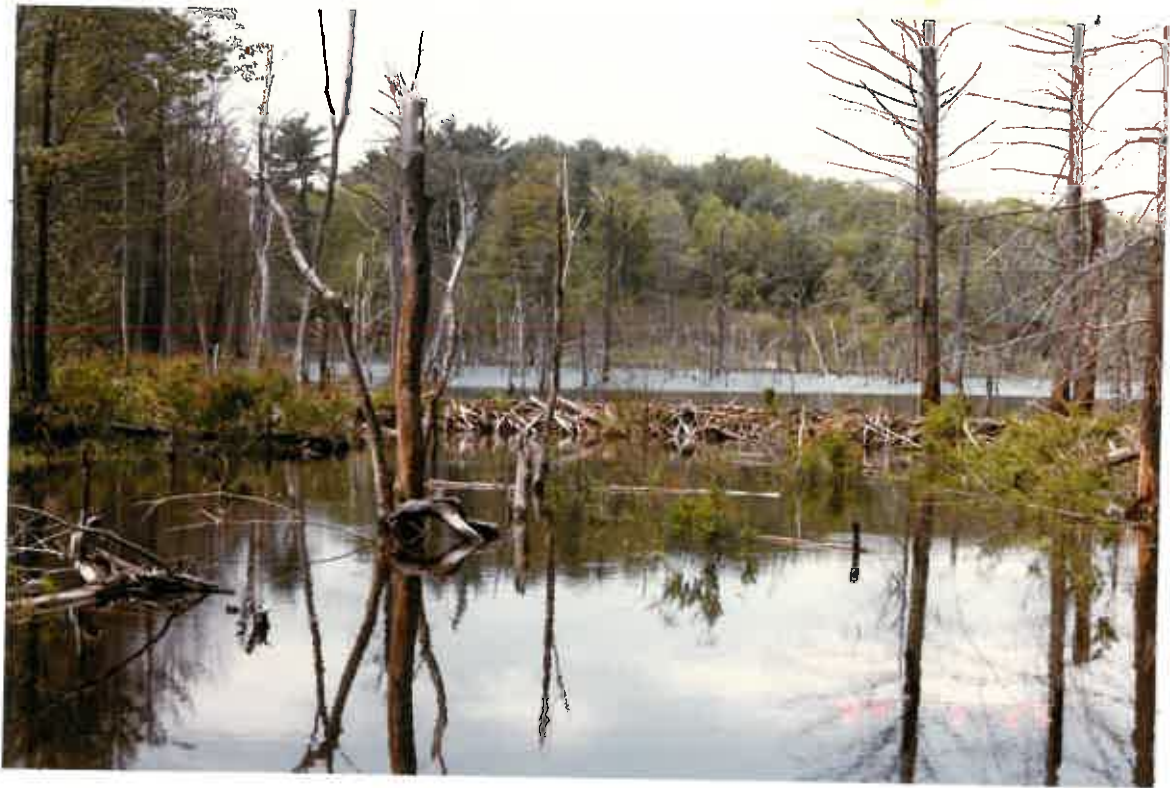
Photo 3. Beaver dam at west side of Goose Pond.

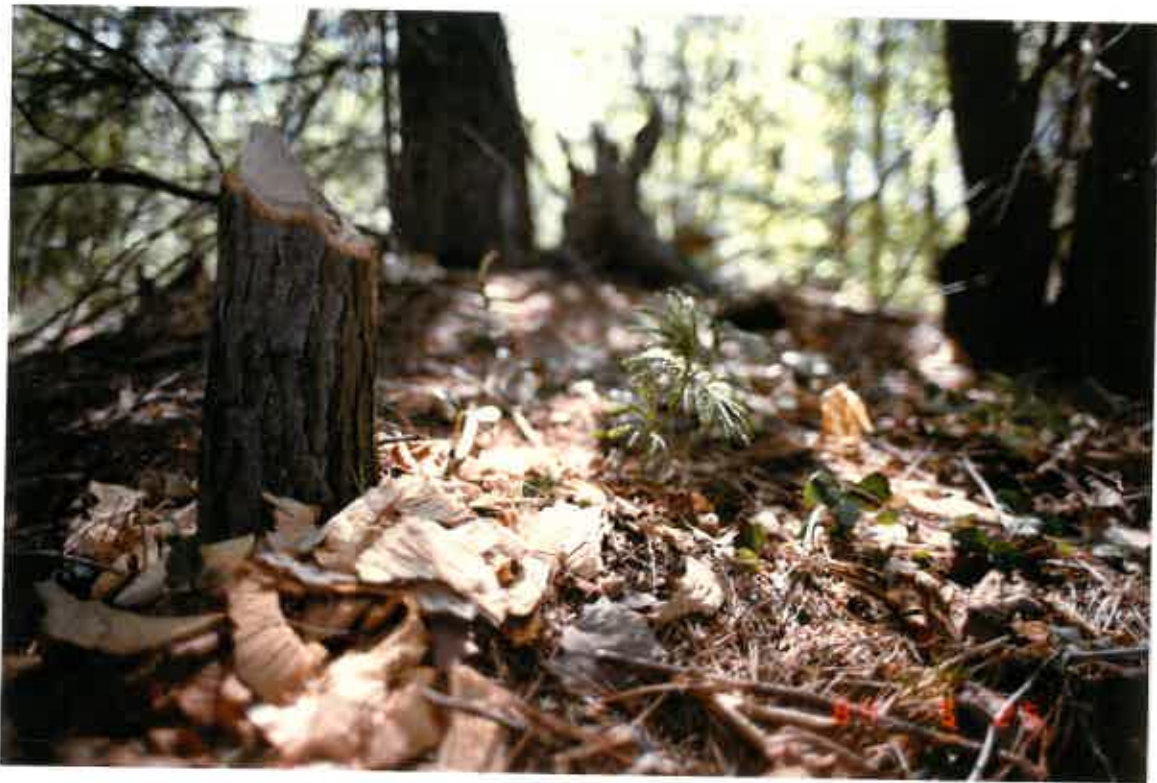
Photo 4. Recent evidence of beaver activity at Goose Pond. The beaver is the most obvious of the many wildlife species found at the site.

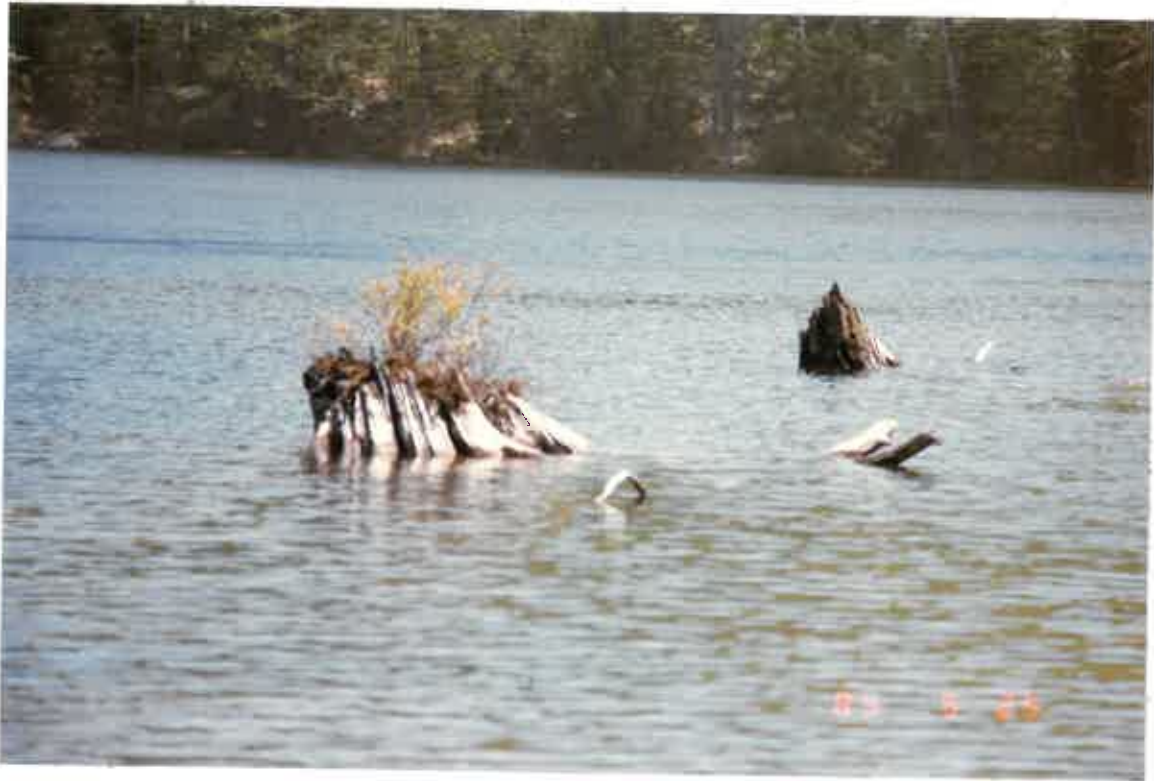
Photo 8. Relict tree stumps, evidencing increased water levels.
