## **Joint Historic District & Heritage Commission**

**SUBJECT:** Assigning a Local Rank for Unranked Properties in the Downtown Historic District

**RESOURCE: 122 West Street**

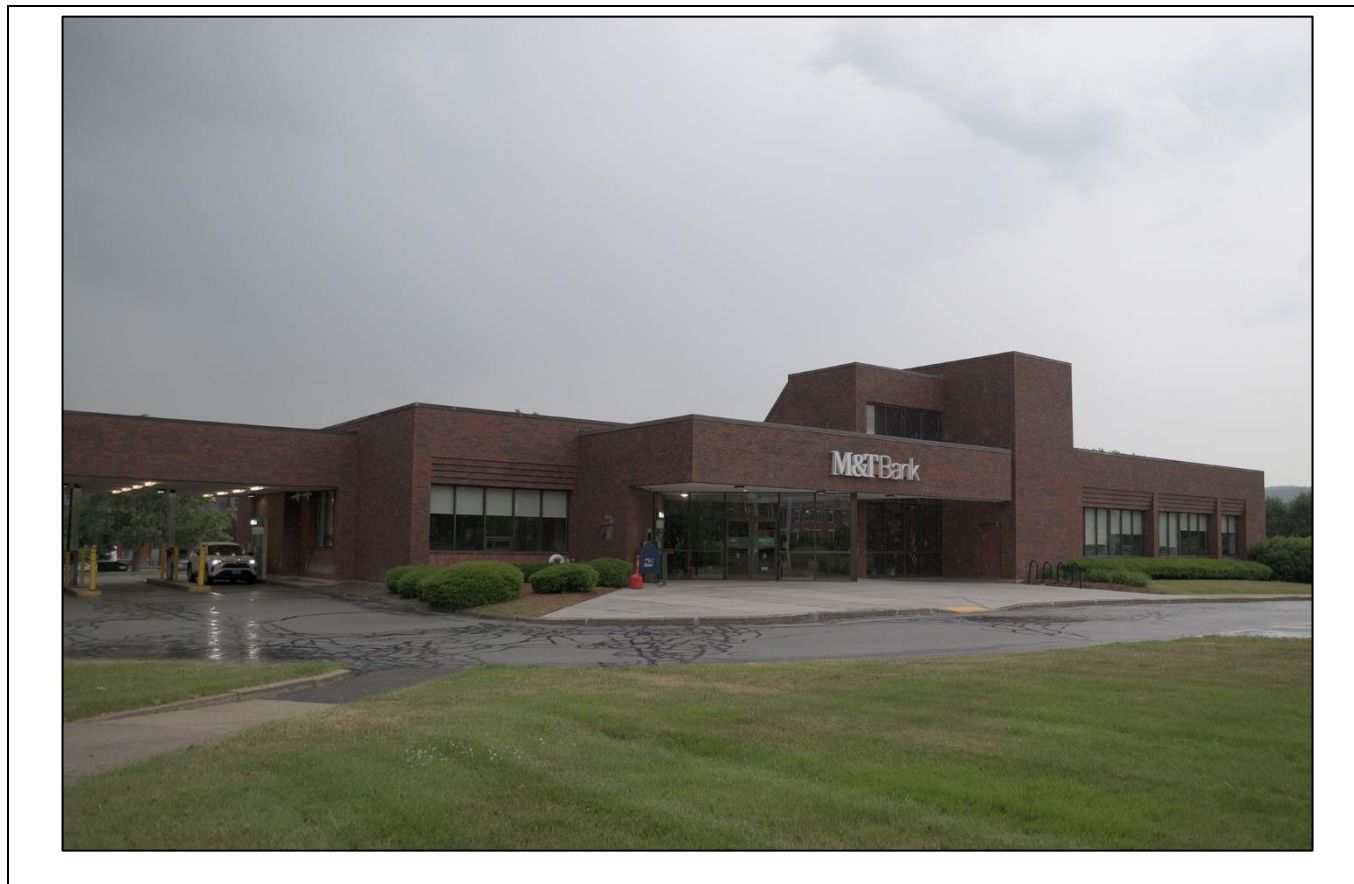
<b>Photo No. 1</b>	122 West St-2024-1.jpg	<b>Date</b>	June 19, 2024	<b>Direction</b>	Southwest
<b>Notes</b>	The People's United Bank has changed very little since it was constructed in 1978 and retains character-defining features such as long, low building profile, angular exterior with projecting massings, flat brick walls, horizontal brick ornamentation, and slightly indented ribbons of large flat windows.

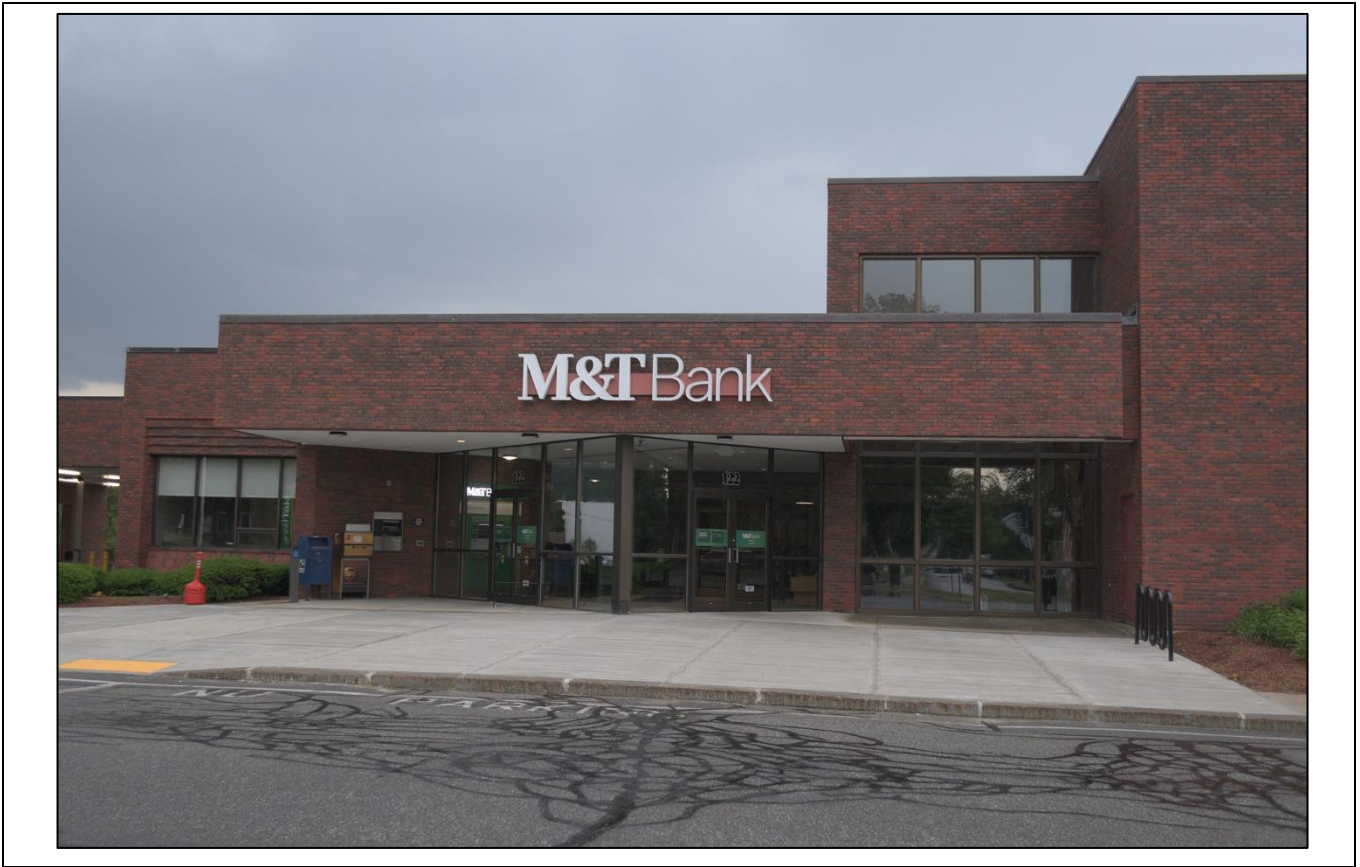
<b>Photo No. 2</b>	122 West St-2024-2.jpg	<b>Date</b>	June 19, 2024	<b>Direction</b>	South
<b>Notes</b>	<p>The cantilevered roof above the primary entrance to the bank provides a sheltered entrance at the prominent corner of the building that can be easily accessed either by pedestrian traffic from Keene’s downtown core or by cars parked in the expansive asphalt parking area. The wall of glass created by the ribbon windows and doors creates a “modern” open lobby, a key features of 1970s financial institutions and one of the character-defining features of the property.</p>

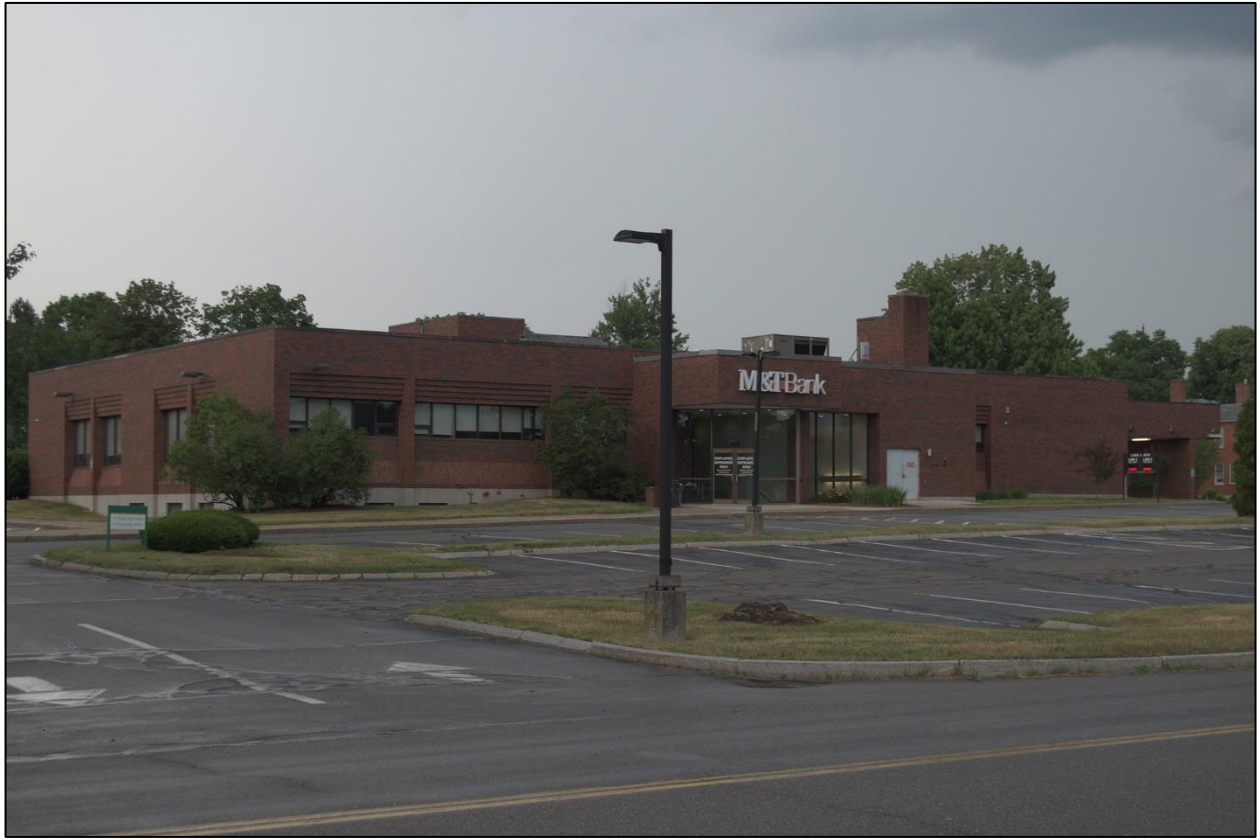
<b>Photo No. 3</b>	122 West St-2024-3.jpg	<b>Date</b>	June 19, 2024	<b>Direction</b>	Northeast
<b>Notes</b>	The rear (north) elevation of the building shares the low profile of the front but is simplified in design with the recessed entry of the primary façade mirrored here in the extremely tall glass windows at the rear entrance at the center of the building. The three-bay drive-through at the east (right) side of the building further emphasizes the strong horizontal lines of the design.

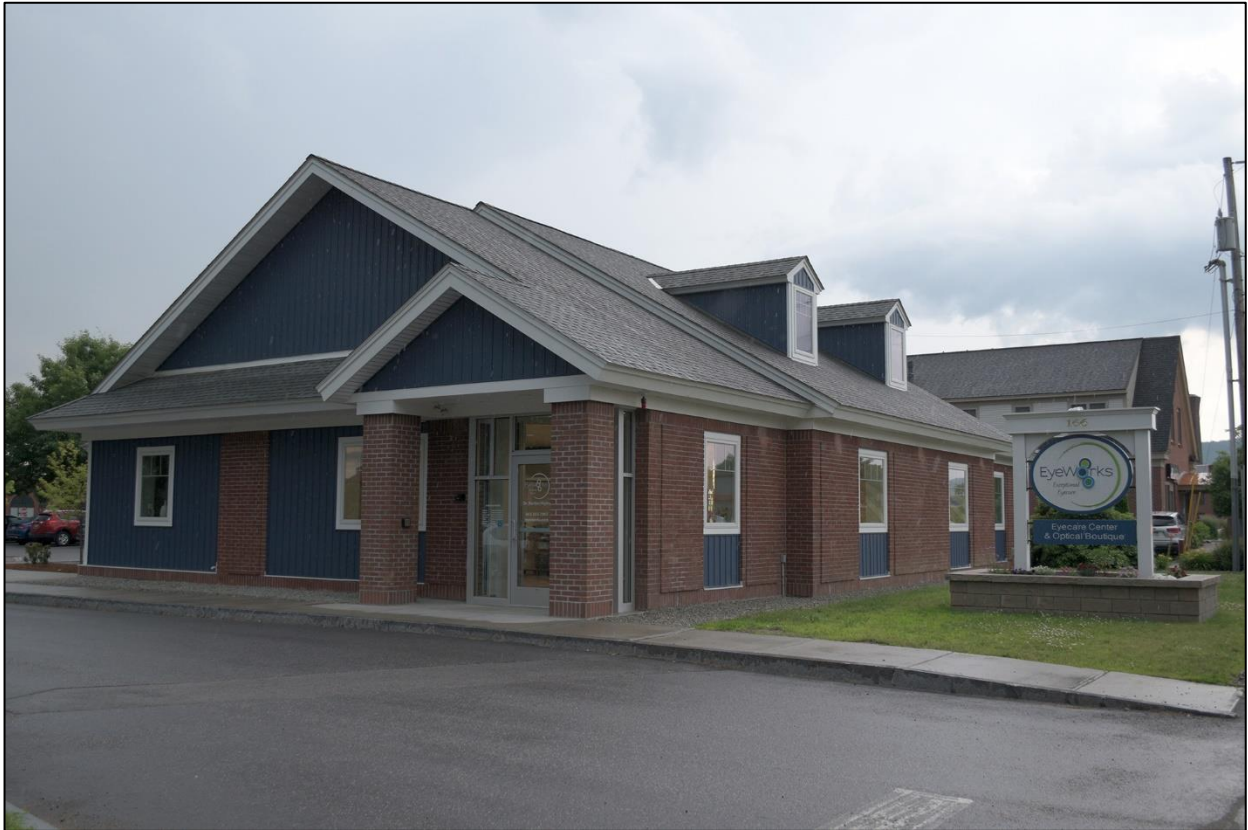
<b>Photo No. 1</b>	Friendlys-2024-1.jpg	<b>Date</b>	June 19, 2024	<b>Direction</b>	Southwest
<b>Notes</b>	The former Friendly's Restaurant, now Eyeworks optometry office was heavily remodeled in 2021 with new windows, exterior doors, and board and batten panels. The general form and massing of the building, however, have remained largely intact and carry-over from the original use as a branded Friendly's Restaurant of the mid-1970s.

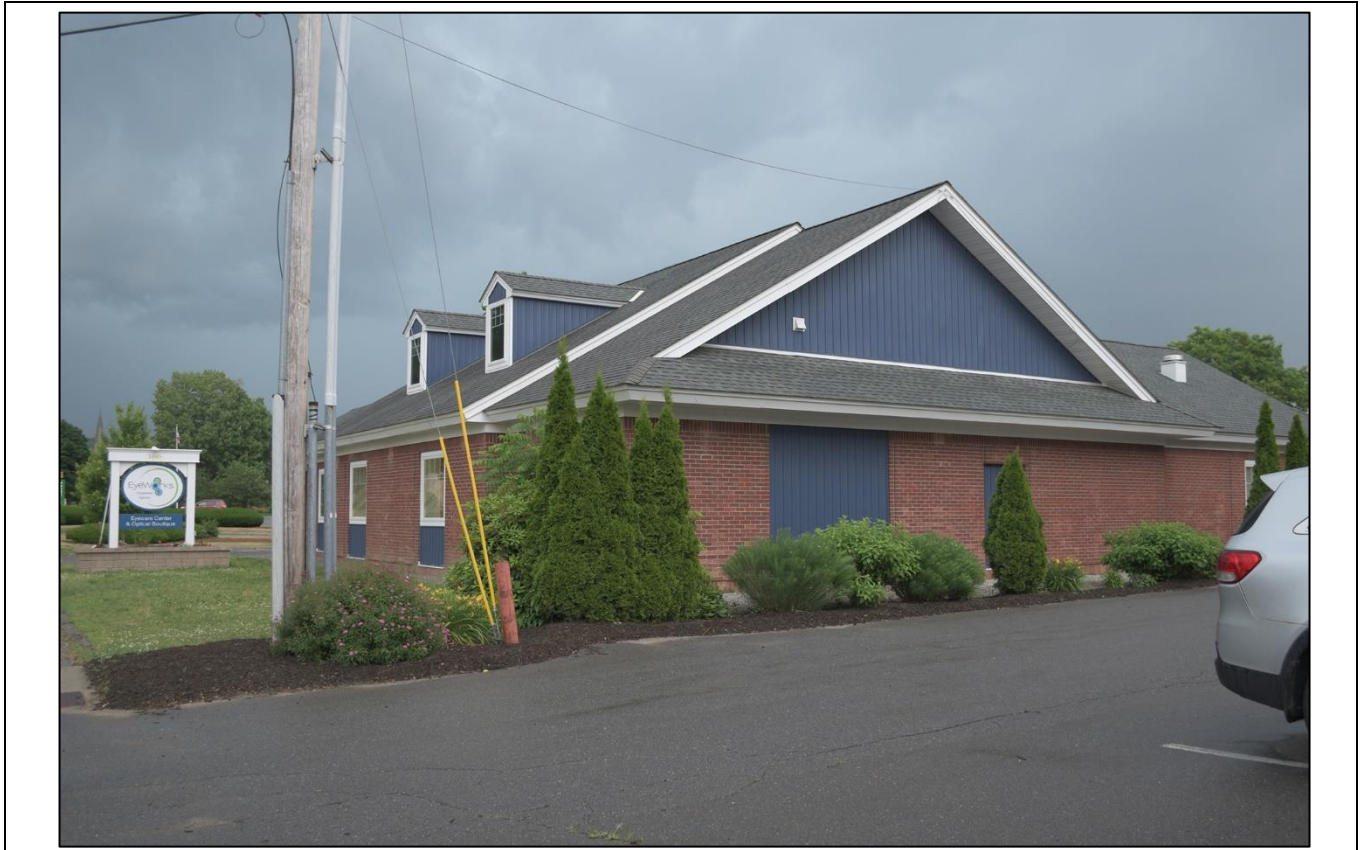
<b>Photo No. 2</b>	Friendlys2024-2.jpg	<b>Date</b>	June 19, 2024	<b>Direction</b>	Southeast
<b>Notes</b>	166 West Street from northwest, facing southeast, showing north and west elevations of former Friendly's Restaurant. Note the paired dormers on the north roof slope, which were a common feature of the Centennial-era corporate-designed fast-food restaurant, supposedly added to create a welcoming face from the roadside.

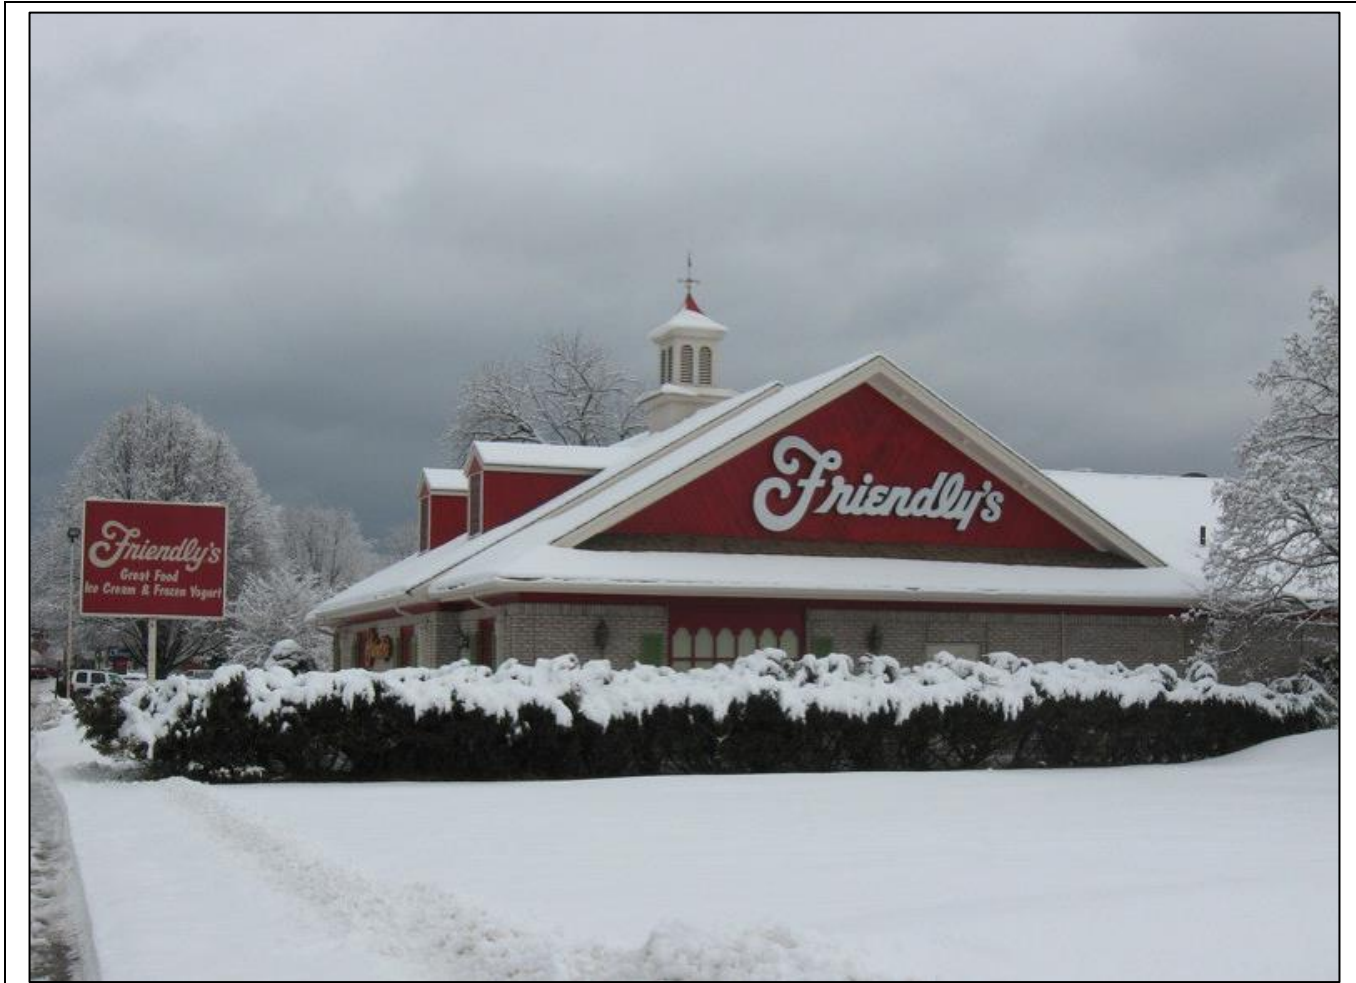
<b>Historic Photo 1</b>	<b>Keene Friendly's Restaurant, ca. 2015</b>	<b>Direction</b>	Southeast
<b>Notes</b>	The Keene friendly's location shut down in April 2019 and was removed for use as the Eyeworks optometry office in 2021. Note the original red and white color scheme, dormer windows and louvered cupola.

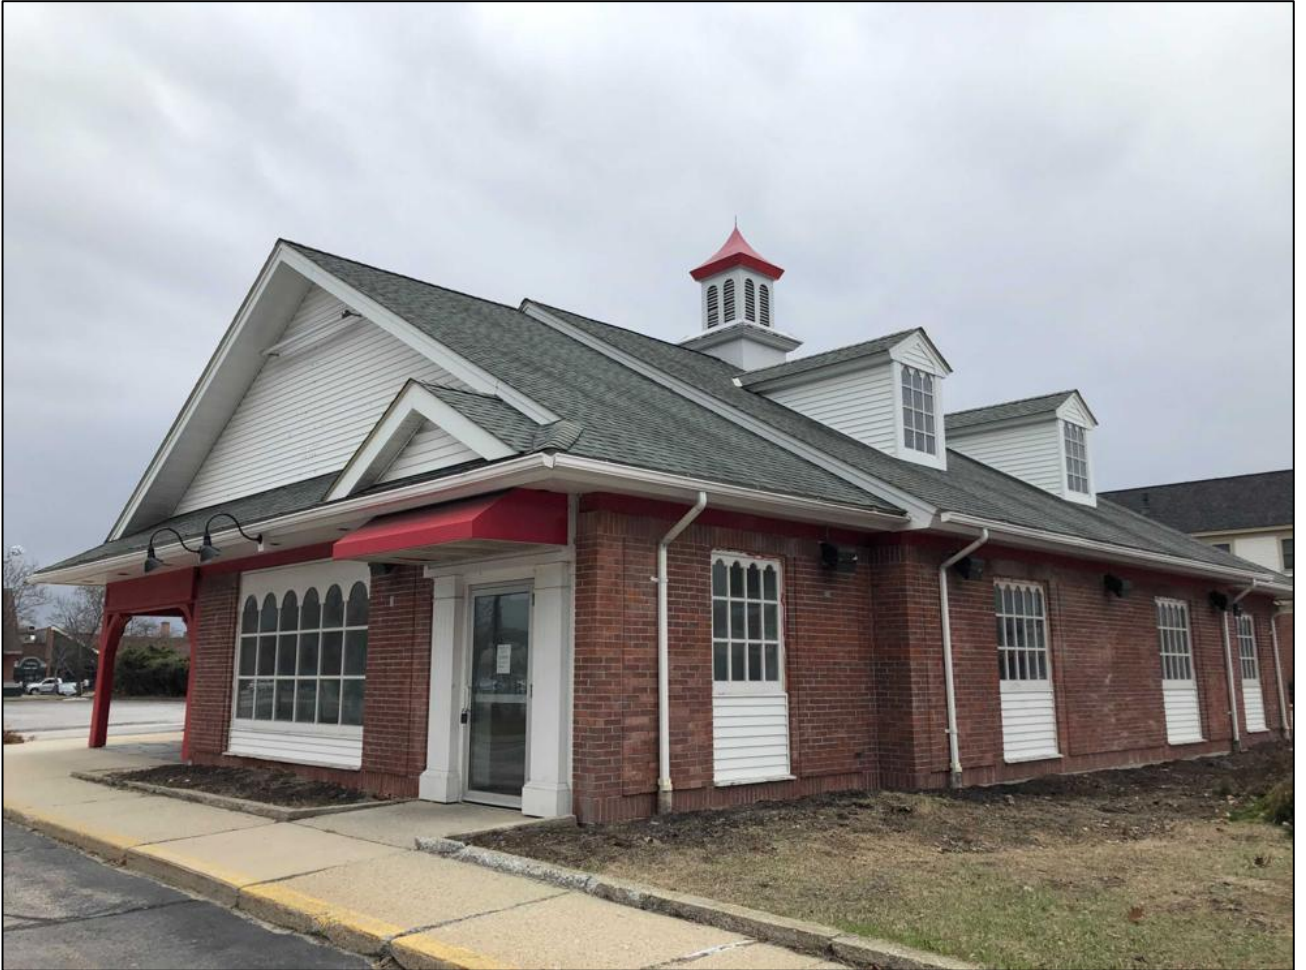
<b>Historic Photo 2</b>	<b>Keene Friendly's Restaurant, 2021</b>	<b>Direction</b>	Southwest
<b>Notes</b>	2021 <i>Keene Sentinel Newspaper</i> photograph of the former Friendly's Restaurant awaiting redevelopment for use for use as the Eyeworks optometry office in 2021. Late 20 <sup>th</sup> century hedges in front of the building are removed in this image, however, the original faux-divided light "colonnaded" windows remain in place.

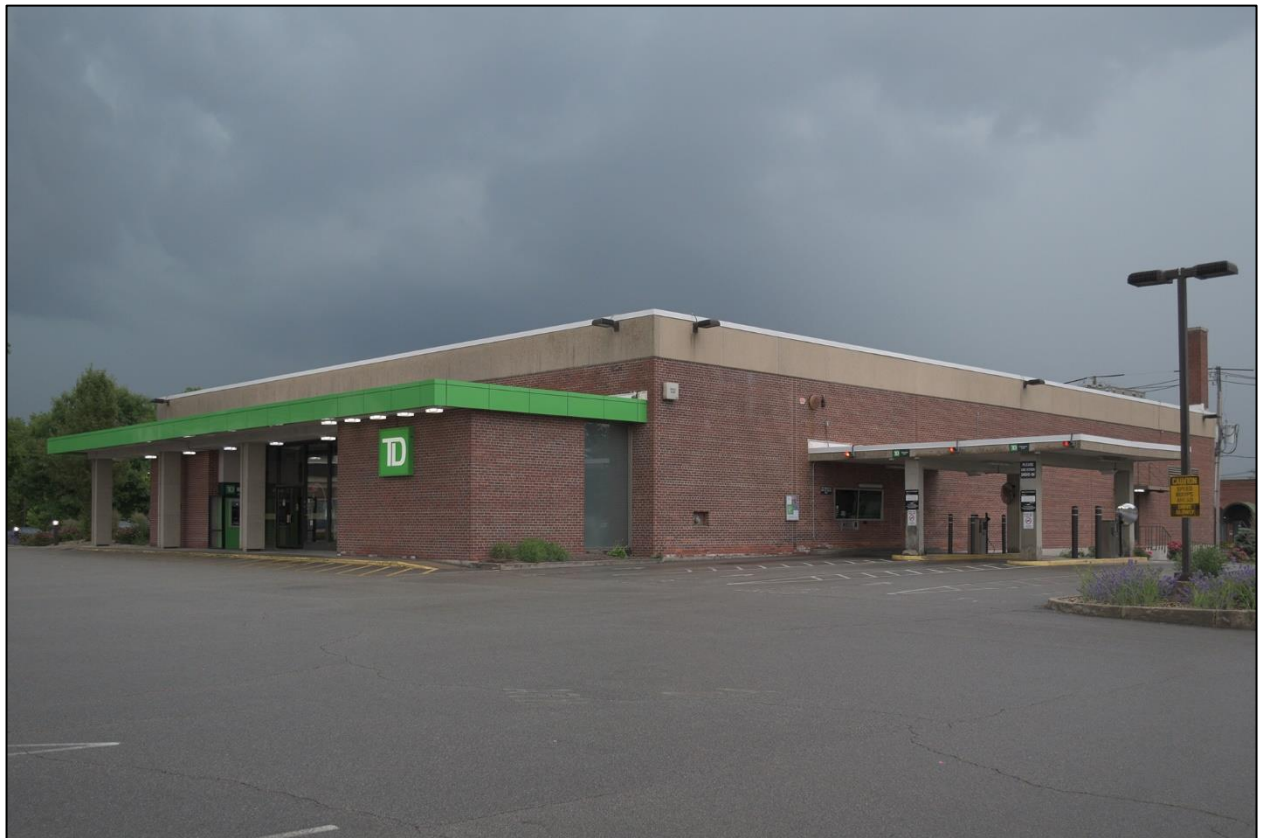
<b>Photo No. 1</b>	194 West St-2024-1.jpg	<b>Date</b>	June 19, 2024	<b>Direction</b>	Southeast
<b>Notes</b>	North and east elevations of the 1972 TD Bank building showing primary bank entrance at left and drive-through at right. Like the nearby People’s United Bank, the building has a long low form with exterior detail emphasizing horizontal lines. The centralized entrance is accessed through a recessed entry porch, with large plate-glass windows creating a light and open atrium at the building interior.

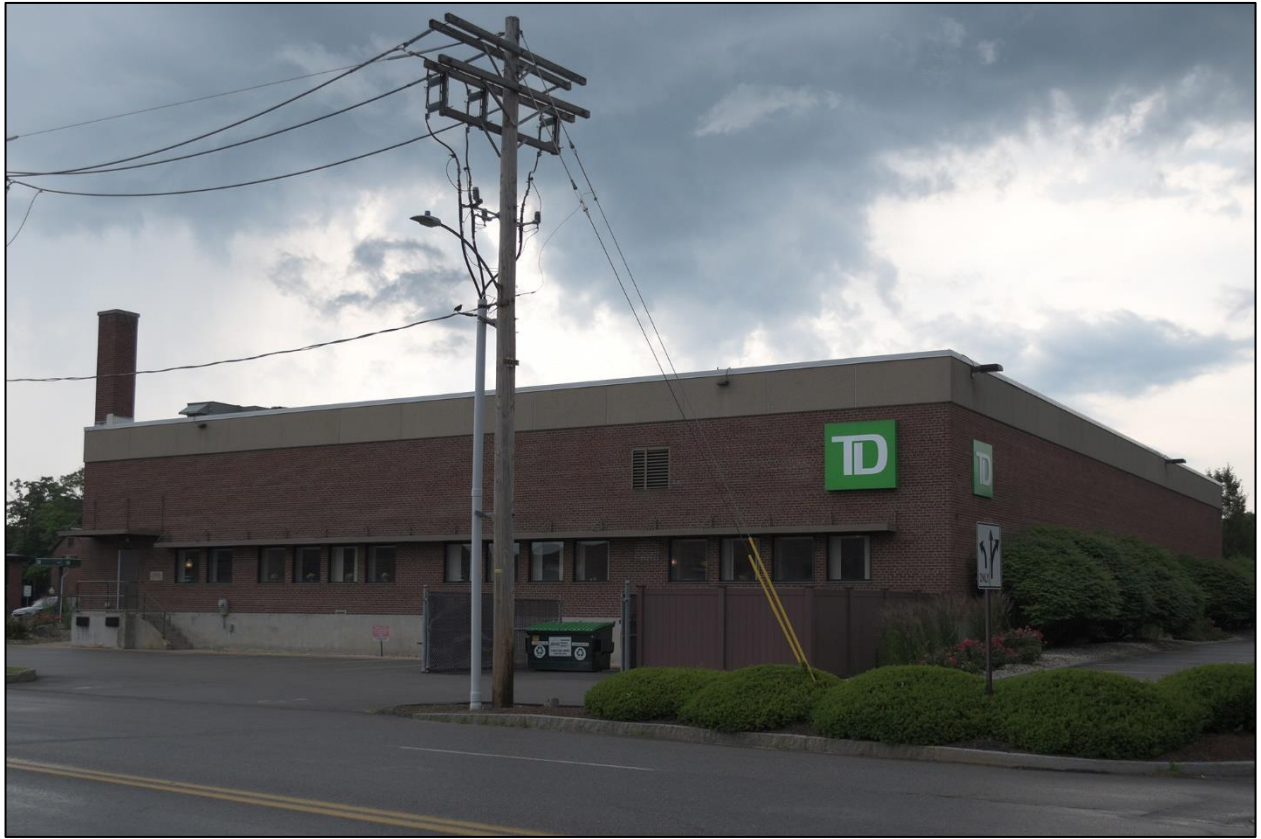
<b>Photo No. 2</b>	194 West St-2024-2.jpg	<b>Date</b>	June 19, 2024	<b>Direction</b>	Northwest
<b>Notes</b>	Rear elevations of bank (south and west) photographed from across Gilbo Avenue.

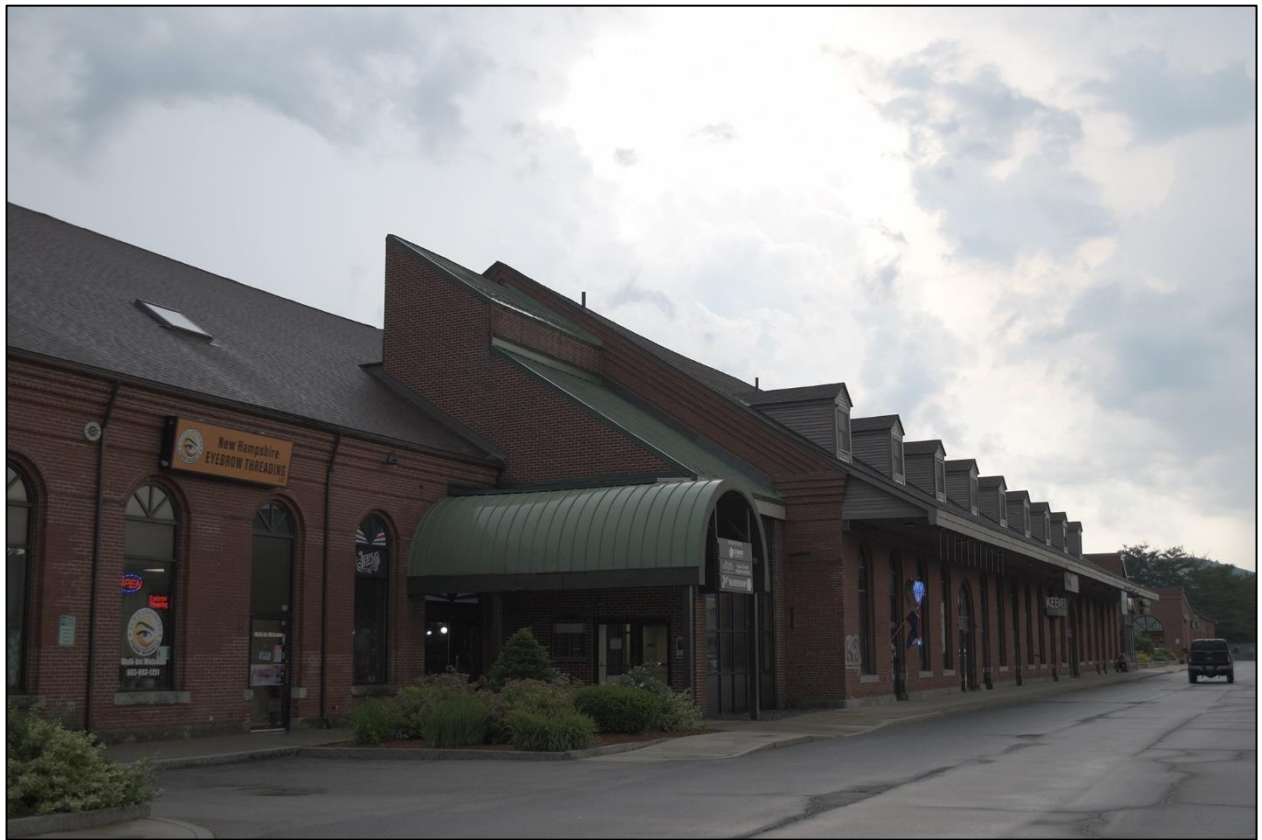
<b>Photo No. 1</b>	149 Emerald-2024-1.jpg	<b>Date</b>	June 19, 2024	<b>Direction</b>	Southwest
<b>Notes</b>	In 1984, the surviving Cheshire Railroad Locomotive Repair Shop, Black Smith & Mechanical Shop, Wood Work, and Car Repair Shops were incorporated into the east end of a large connected mini-mall. This image shows a modern entrance at the intersection of the Blacksmith and Locomotive repair shops.

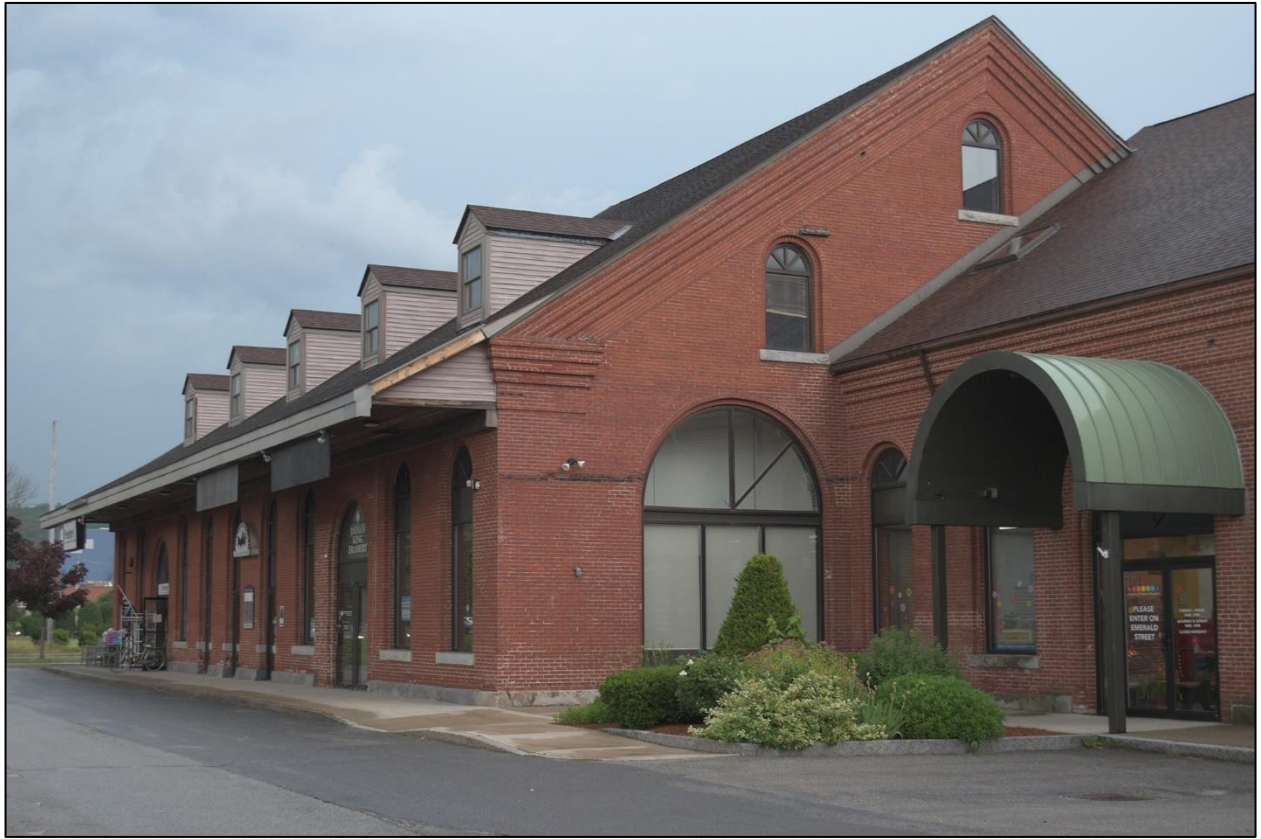
<b>Photo No. 2</b>	149 Emerald-2024-2.jpg	<b>Date</b>	June 19, 2024	<b>Direction</b>	Southeast
<b>Notes</b>	<p>The historic connected wood working and car repair/erector’s shops at the eastern terminus of the mall retain several character-defining features from the historic period including overall form and massing, corbelled brick at the gable end, wood-clapboarded dormer windows along the north roof slope, and semi-circular arched fenestration (door and window) openings. The doors and windows along with the semi-circular awning over the entrance at the right side of the image (which leads into the historic Black Smith and Machine Shop) were added in 1984 when the original doors and windows were removed and the eaves were extended to shelter the new sidewalk. The the loss of original windows and doors represents some loss of integrity of design, materials, and workmanship to the Railroad era, however, the way in which the historic buildings were reused as part of the 1984 mini-mall and the features from that era may retain integrity to that era, as a late example of the “Mansard style” which was popular in commercial architecture from about 1960 through the late 1970s and as an example of mini-mall architecture.</p>

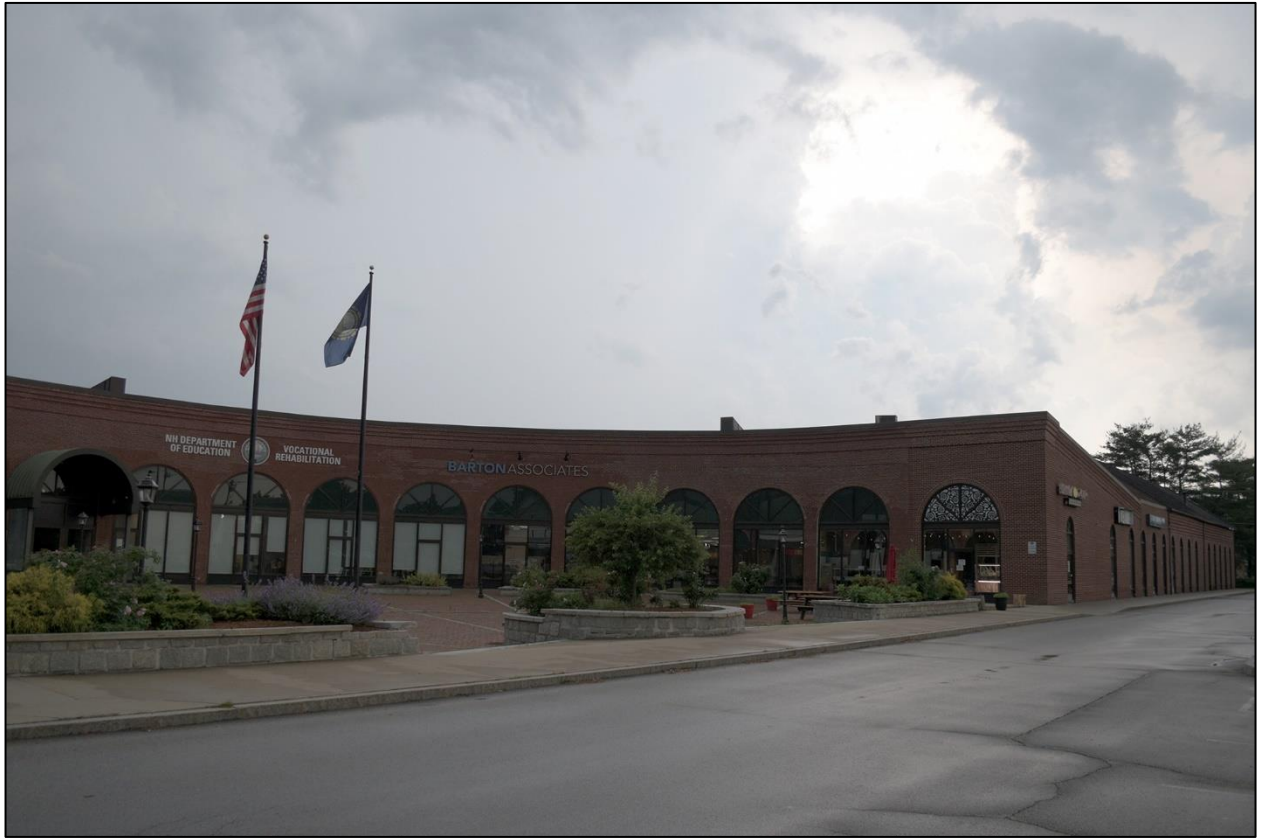
<b>Photo No. 3</b>	149 Emerald-2024-3.jpg	<b>Date</b>	June 19, 2024	<b>Direction</b>	Southwest
<b>Notes</b>	<p>The historic Cheshire Railroad roundhouse is incorporated into this section of the mall, which was a very important feature of the railyard. This section of the building incorporates large semi-circular plate-glass windows into the historically open bays. A sheltered courtyard in the middle of the semi-circle was once occupied by the historic turntable.</p>

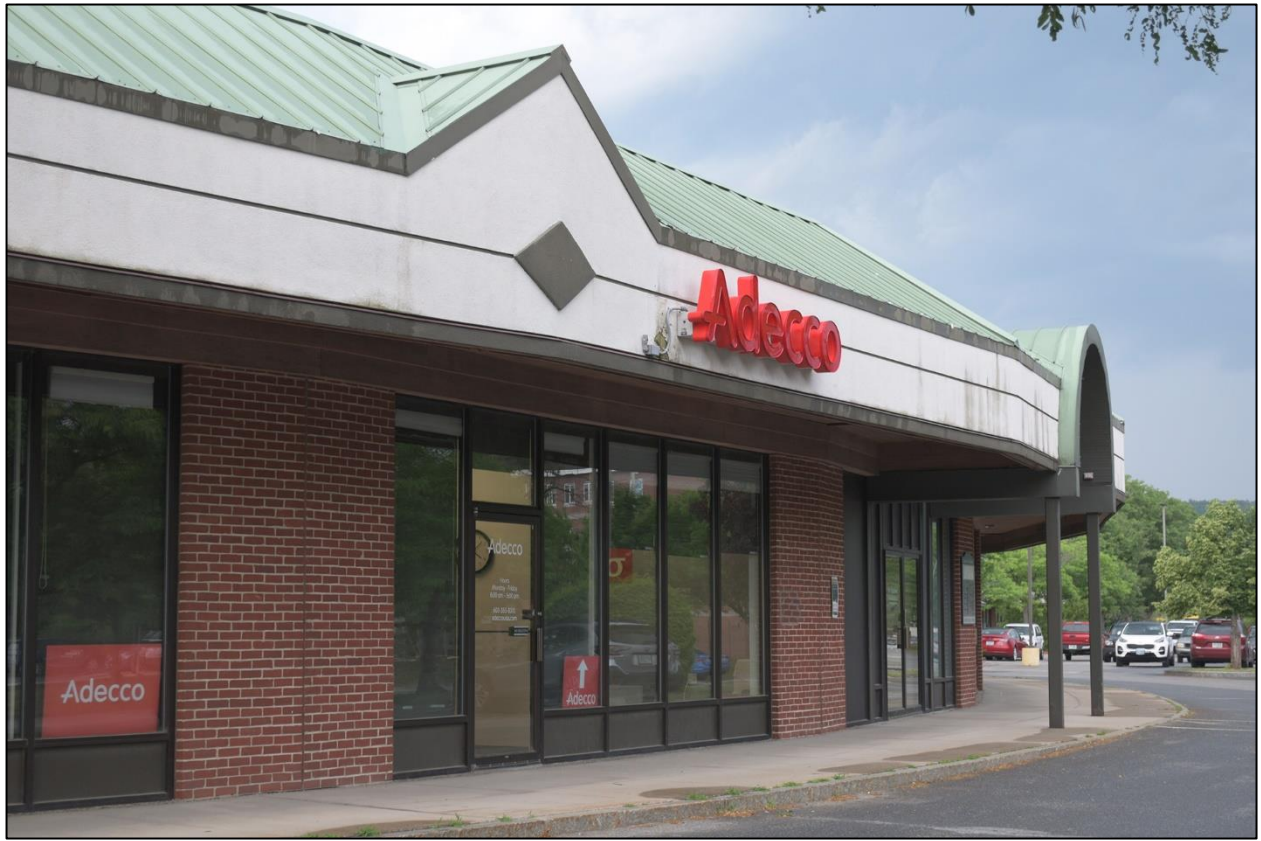
<b>Photo No. 4</b>	149 Emerald-2024-4.jpg	<b>Date</b>	June 19, 2024	<b>Direction</b>	East
<b>Notes</b>	<p>The south side of the shopping mall is purely modern construction, having been added onto the historic portion of the structure in 1984. The modern mini-mall is typically early to mid-1980s in style with a covered exterior pedestrian walkway and banded glass and metal shop windows at each storefront. The flat upper roof and standing-seam “mansard” along with semi-circular arched openings are also common features of commercial (mall) architecture form this period. Although too recent to be evaluated for National Register eligibility, these 1980s features may be evaluated in the future as representative of early- to mid-1980s design.</p>

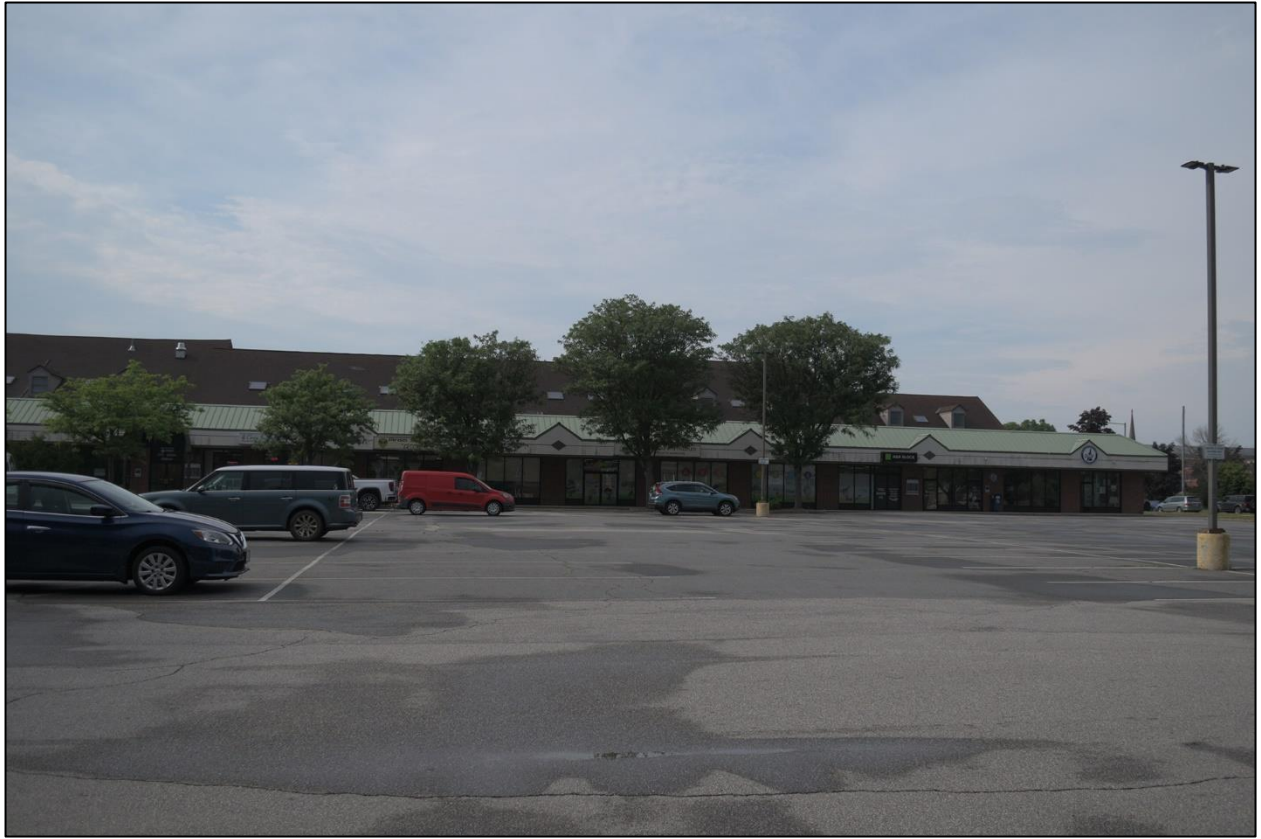
<b>Photo No. 5</b>	149 Emerald-2024-5.jpg	<b>Date</b>	June 19, 2024	<b>Direction</b>	Northeast
<b>Notes</b>	The Center at Colony Mill mall as viewed from across the parking area off of Emerald Street to the south. The single-story structure in the foreground is the 1984 mini-mall addition, and the gable-roof visible beyond it is the south roof slope of the connected mid-19 <sup>th</sup> century Cheshire Railroad shops. Viewed from the south, the Mall is purely 1980s in design, whereas, from the north elevation one still read some of the important 19 <sup>th</sup> century history of the site in the existing, though heavily renovated, building.

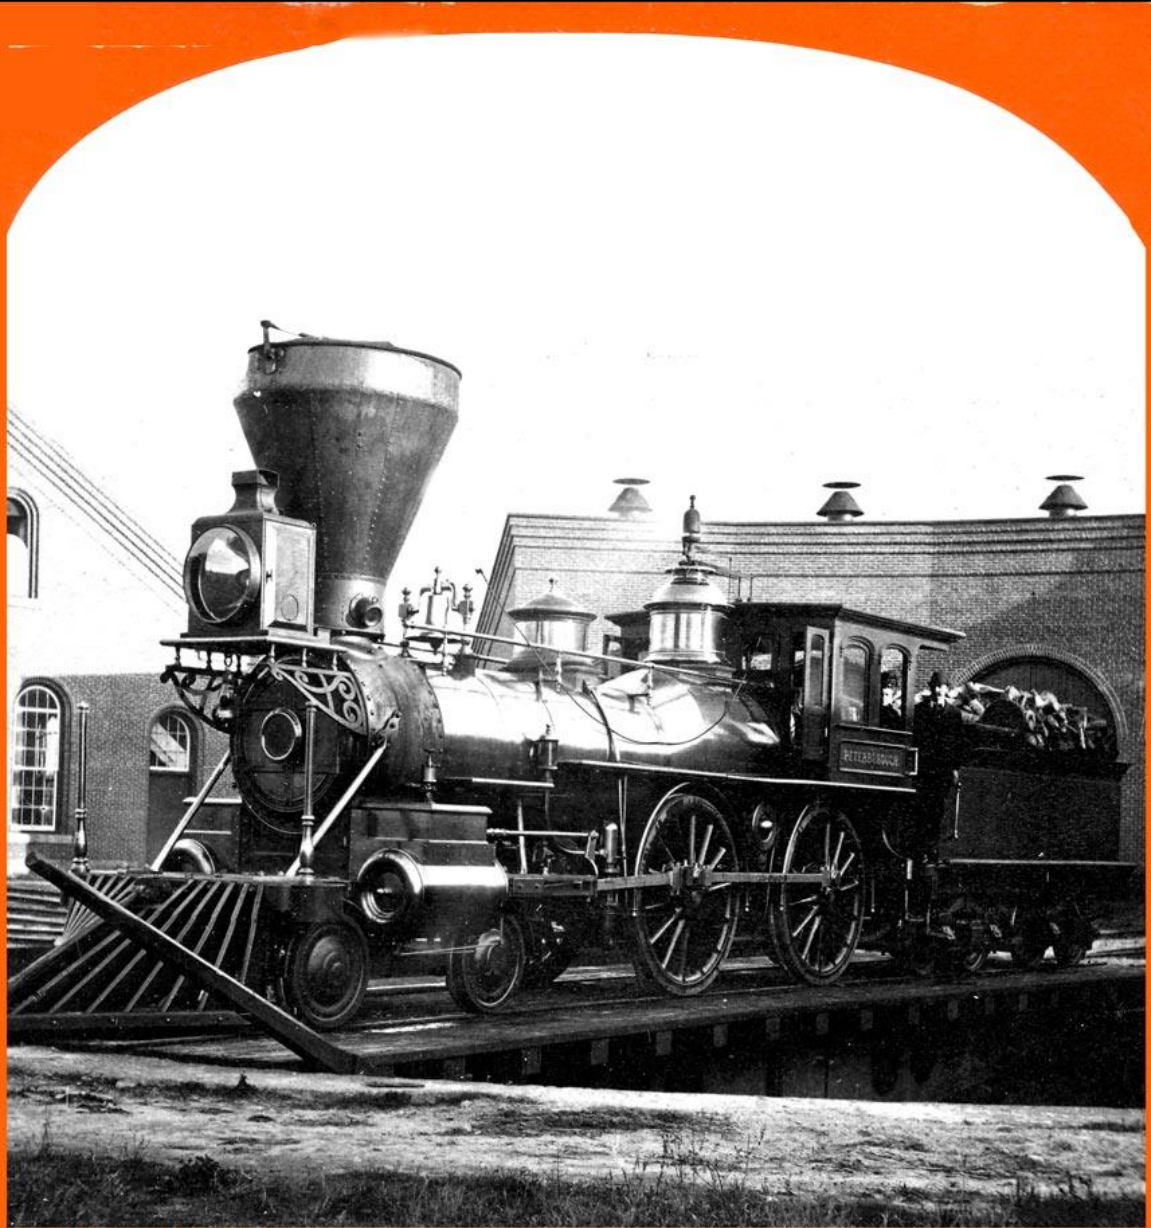
<b>Historic Photo 1</b>	<b>Cheshire Railroad Locomotive "Peterboro" at Keene Roundhouse, ca. 1870</b>	<b>Direction</b>	Southeast
<b>Notes</b>	Stereographic view of a railroad locomotive in front of the Keene roundhouse taken by J. A. French in about 1870. At left is the west elevation of the Locomotive Repair Shop, and the Round House occupies the right background. The end of the Repair shop is currently hidden behind an early 1980s addition (Courtesy Keene Public Library/Historical Society of Cheshire County).

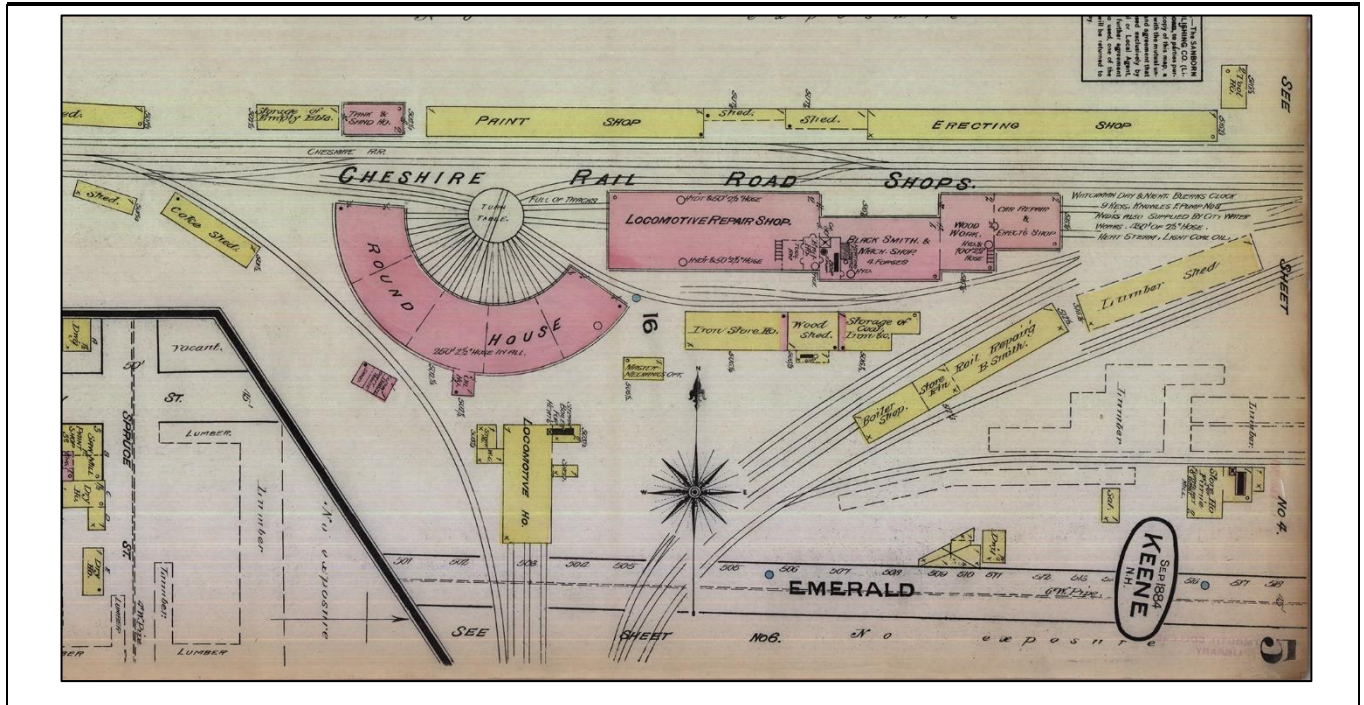
<b>Historic Photo 2</b>	<b>1884 Sanborn Fire Insurance Map, Sheet 5</b>	<b>Direction</b>	N/A
<b>Notes</b>	1884 Sanborn Fire Insurance Map of Keene, showing the Cheshire County Railroad shops, including the Round House and the connected buildings that now make up the east end of the Center at Colony Mill Shopping Center (IE: Locomotive Repair Shop, Blacksmith & Machine Shop; Wood Working Shop, and Car Repair/Erector's Shop). The insurance map also shows additional historic (although non-extant wood-frame buildings). (Dartmouth College, Digital Collections)

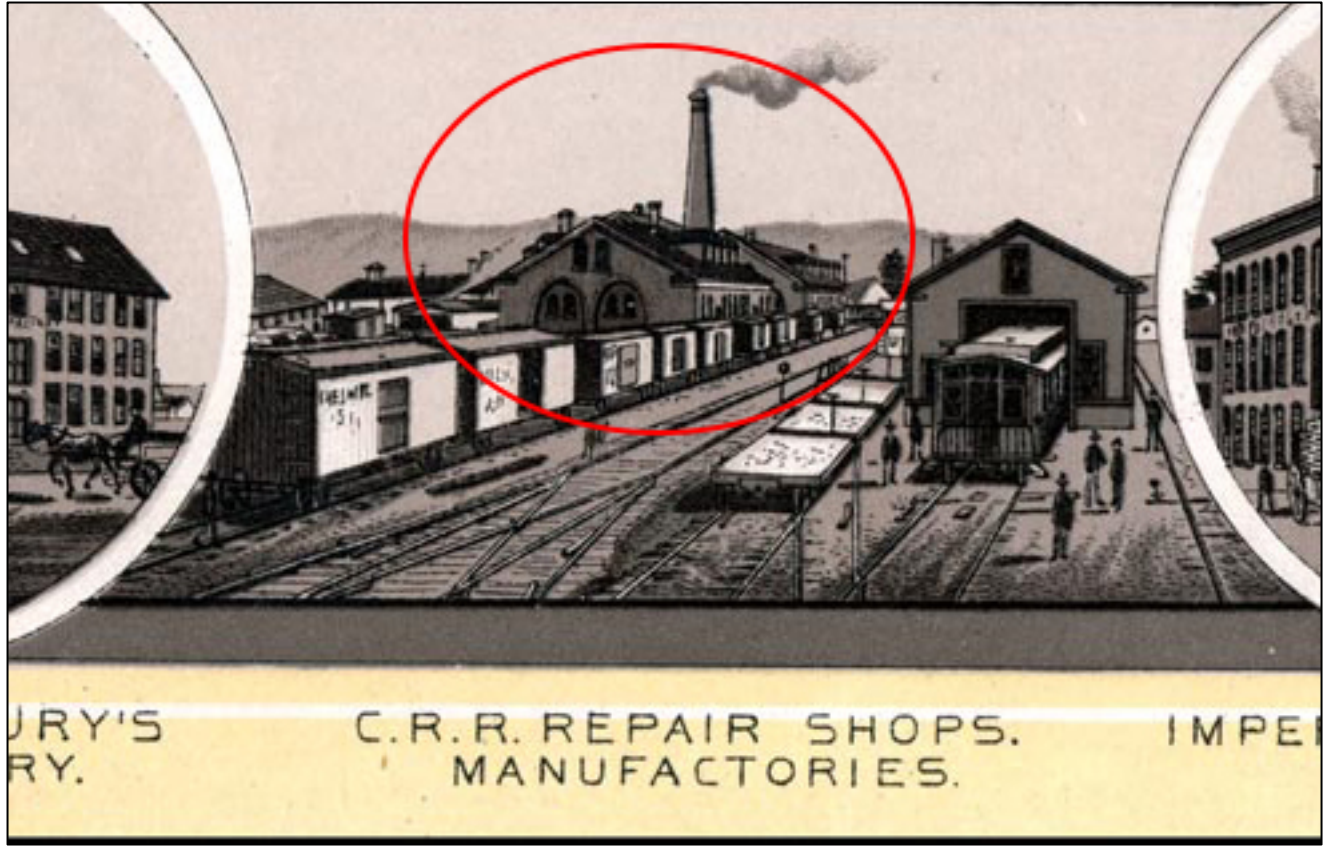
<b>Historic Photo 3</b>	<b>Cheshire RR Repair Shops.</b>	<b>Direction</b>	West
<b>Notes</b>	Excerpt from the “Industries of Keene” showing the Cheshire Railroad repair shops that are incorporated into the east end of the Center at Colony Mill mall. Note that there was once a large chimney stack between the buildings that is no longer extant and that the eaves of the former Car Repair Shop were heavily extended in 1984 when the property was reimagined as a mini-mall (Keene Public Library)

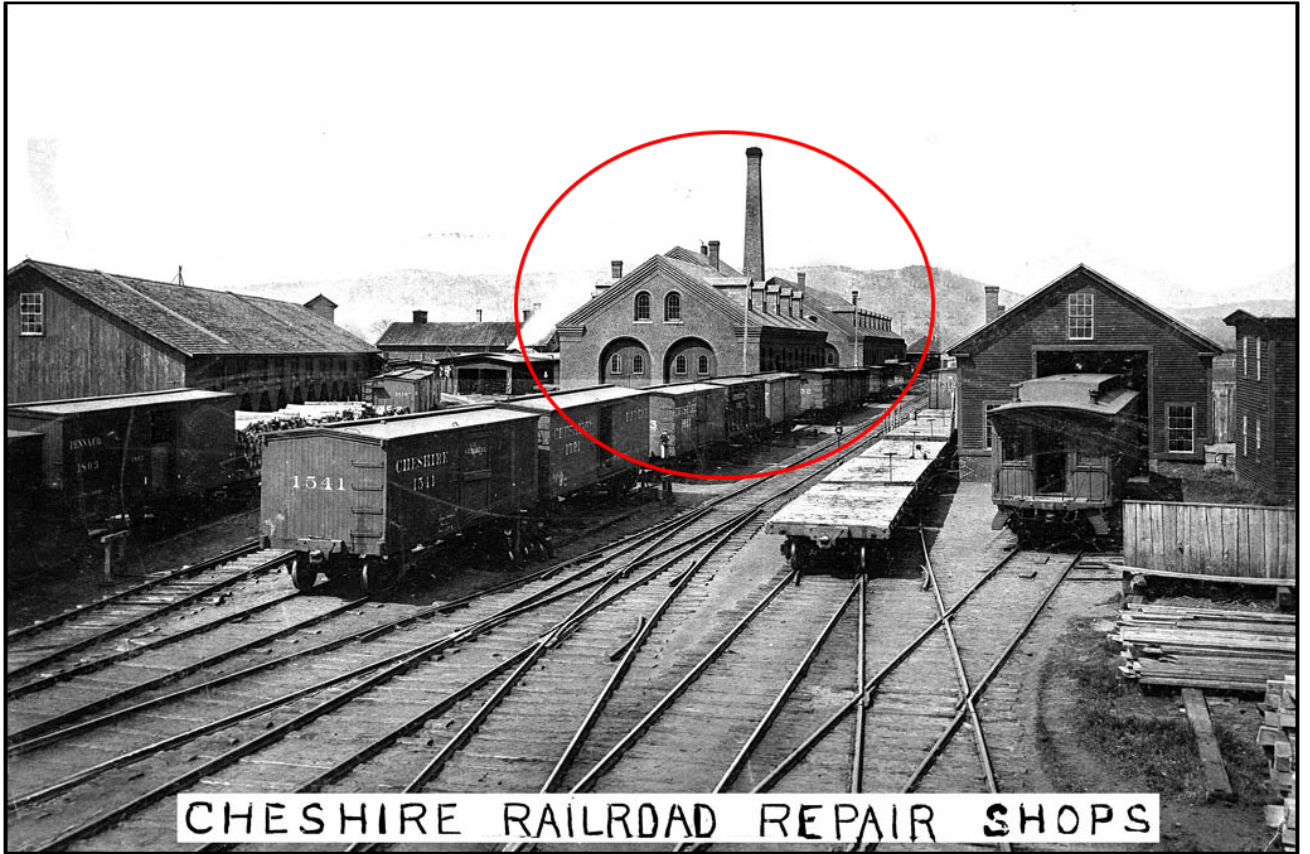
<b>Historic Photo 4</b>	<b>Cheshire Railroad Repair Shops</b>	<b>Direction</b>	West
<b>Notes</b>	Autoglyph print of the Cheshire Railroad repair shops, taken before 1886 by W. P. Allen of Gardner, Massachusetts. The brick buildings were built in 1866 and designed by master mechanic, Francis A. Perry. The shops started building locomotive sin 1868 (Keene Public Library).
