## **Joint Historic District & Heritage Commission**

**SUBJECT:** Assigning a Local Rank for Unranked Properties in the Downtown Historic District

**RESOURCE: 122 West Street**

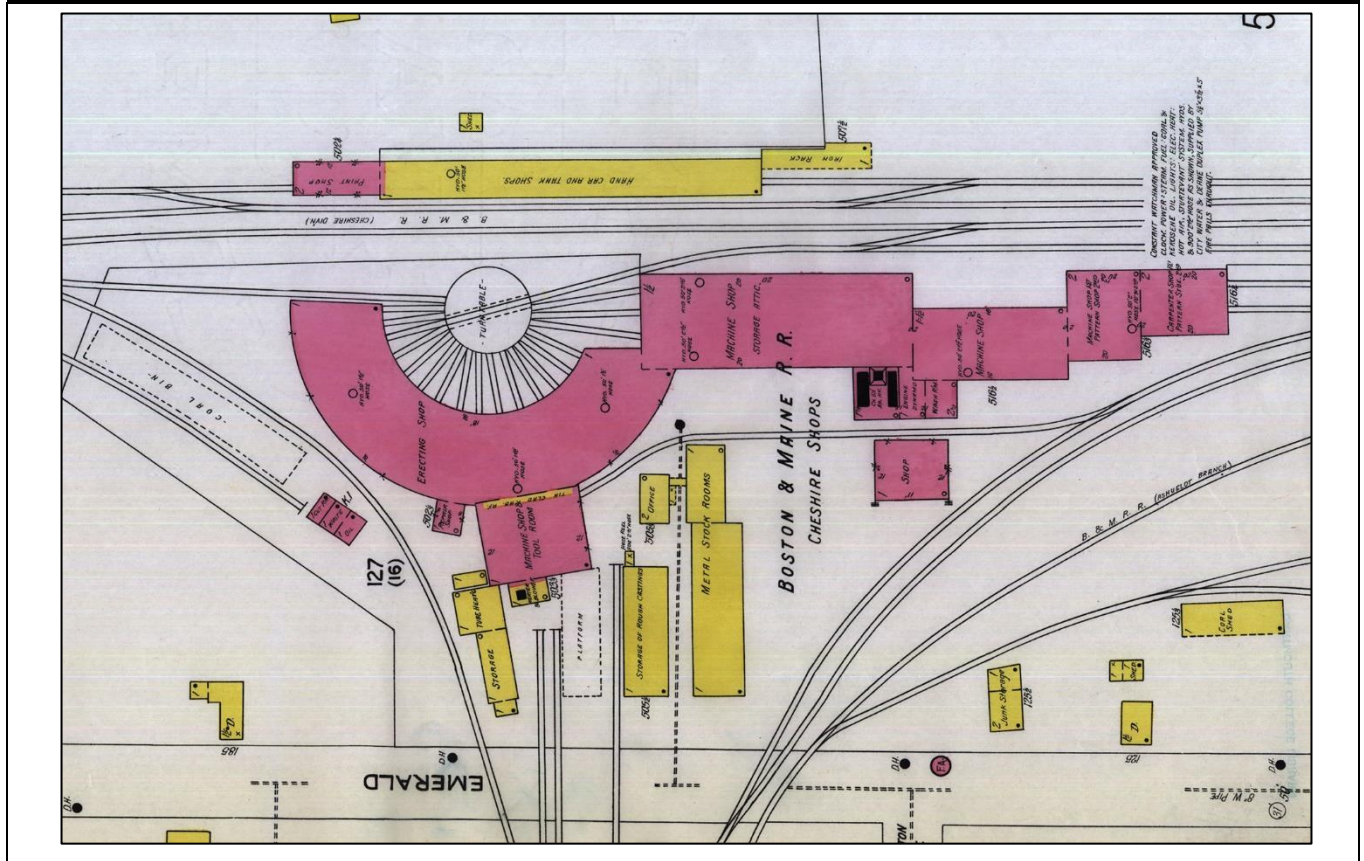
Historic Photo 5	1924 Sanborn Fire Insurance Map, Sheet 7	Direction	N/A
Notes	By 1924, the Boston & Maine Railroad were operating the shops, using the 1866 buildings as an Erecting Shop, Machine Shop, Machine Shop, Machine/Pattern Shop, and Carpenter's Shop. Note that there was a small brick structure at the south side that incorporated a large chimney stack that is no longer present.

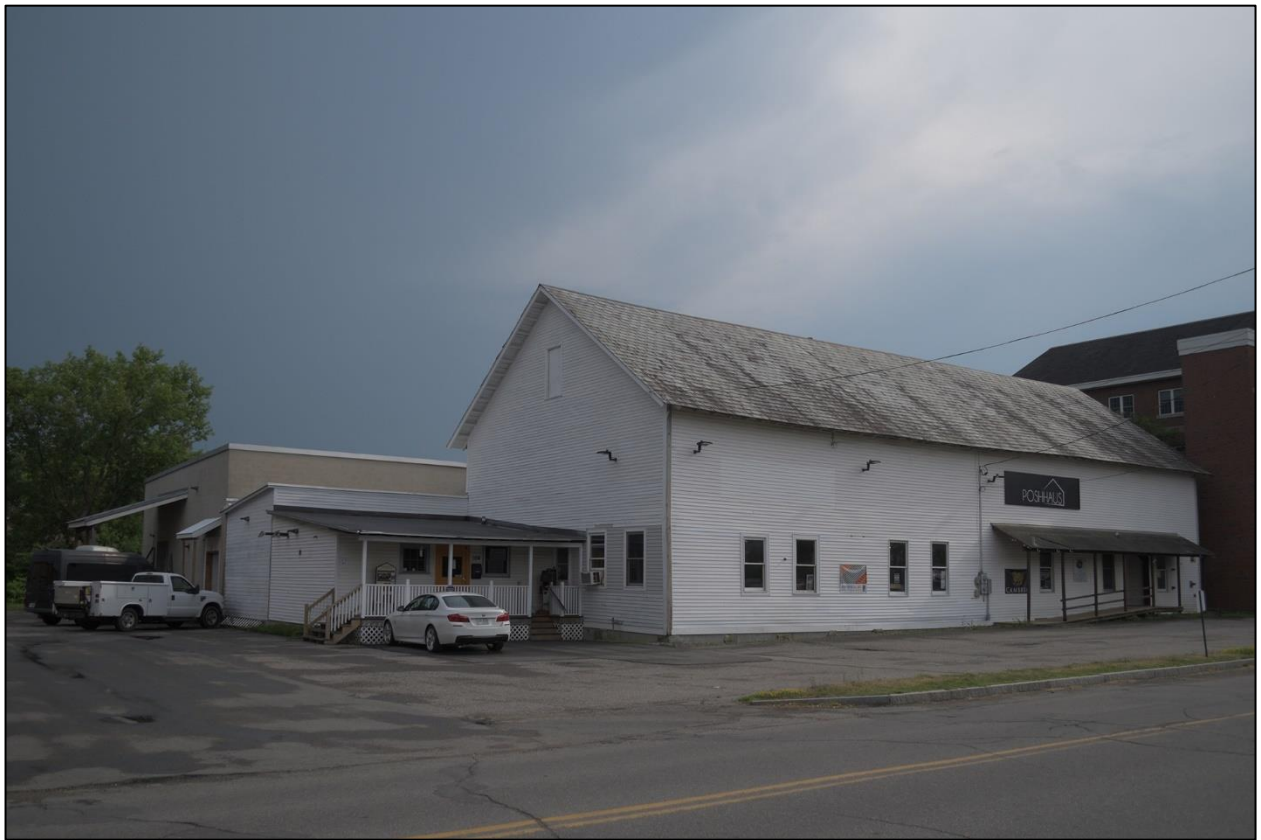
<b>Photo No. 1</b>	104 Emerald-2024.1.jpg	<b>Date</b>	June 19, 2024	<b>Direction</b>	Southwest
<b>Notes</b>	The historic Dunn & Salisbury lumber storage and office building was constructed around the turn of the 20 <sup>th</sup> century and was home to Keene Industrial Paper Company in the early 21 <sup>st</sup> century.

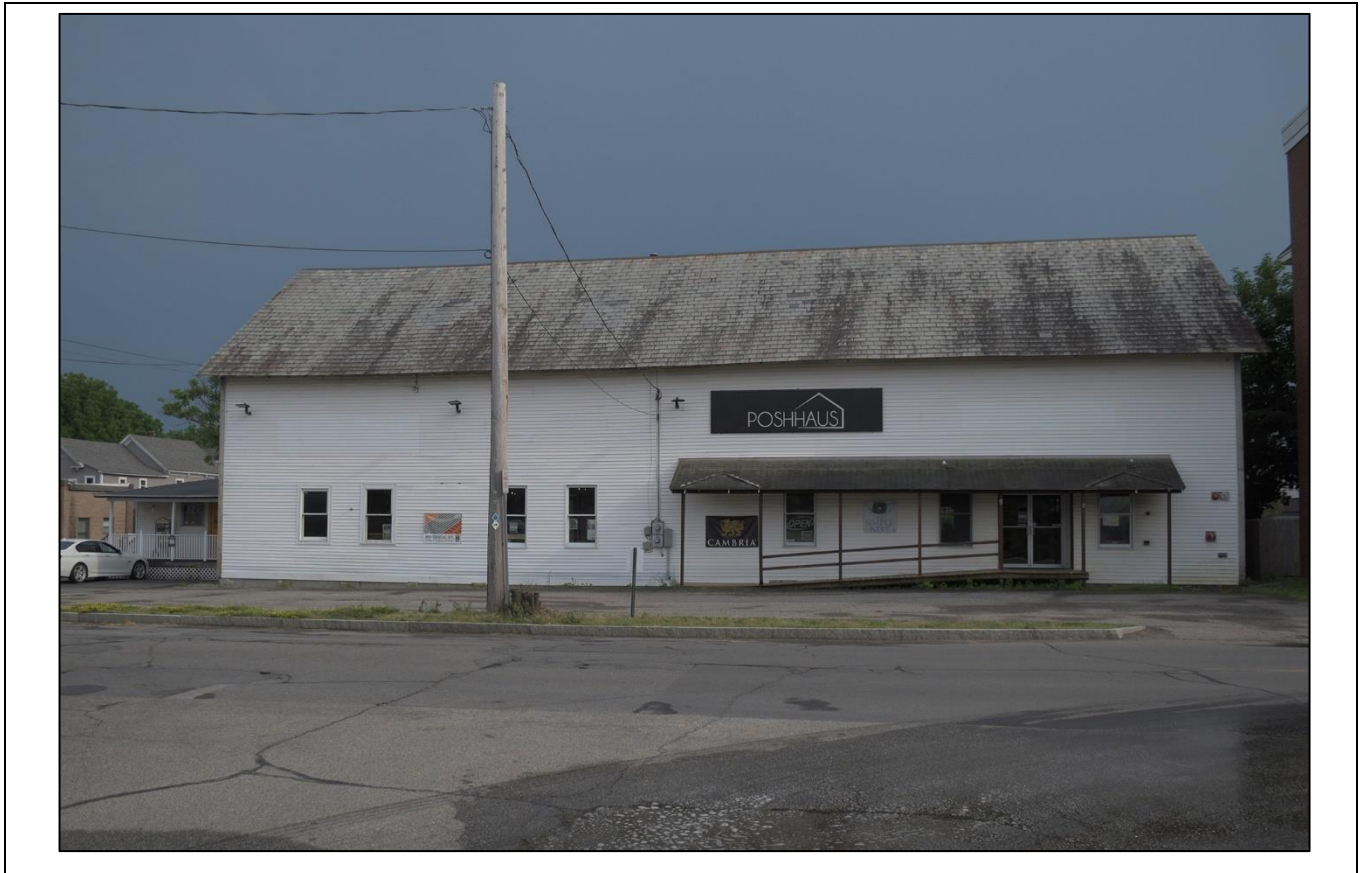
<b>Photo No. 2</b>	104 Emerald-2024-2.jpg	<b>Date</b>	June 19, 2024	<b>Direction</b>	South
<b>Notes</b>	Though the wooden clapboard exterior was covered in vinyl siding, the original slate roof with exposed rafter-tails remains to show the previous use as simply constructed and fire-resistant industrial storage building.

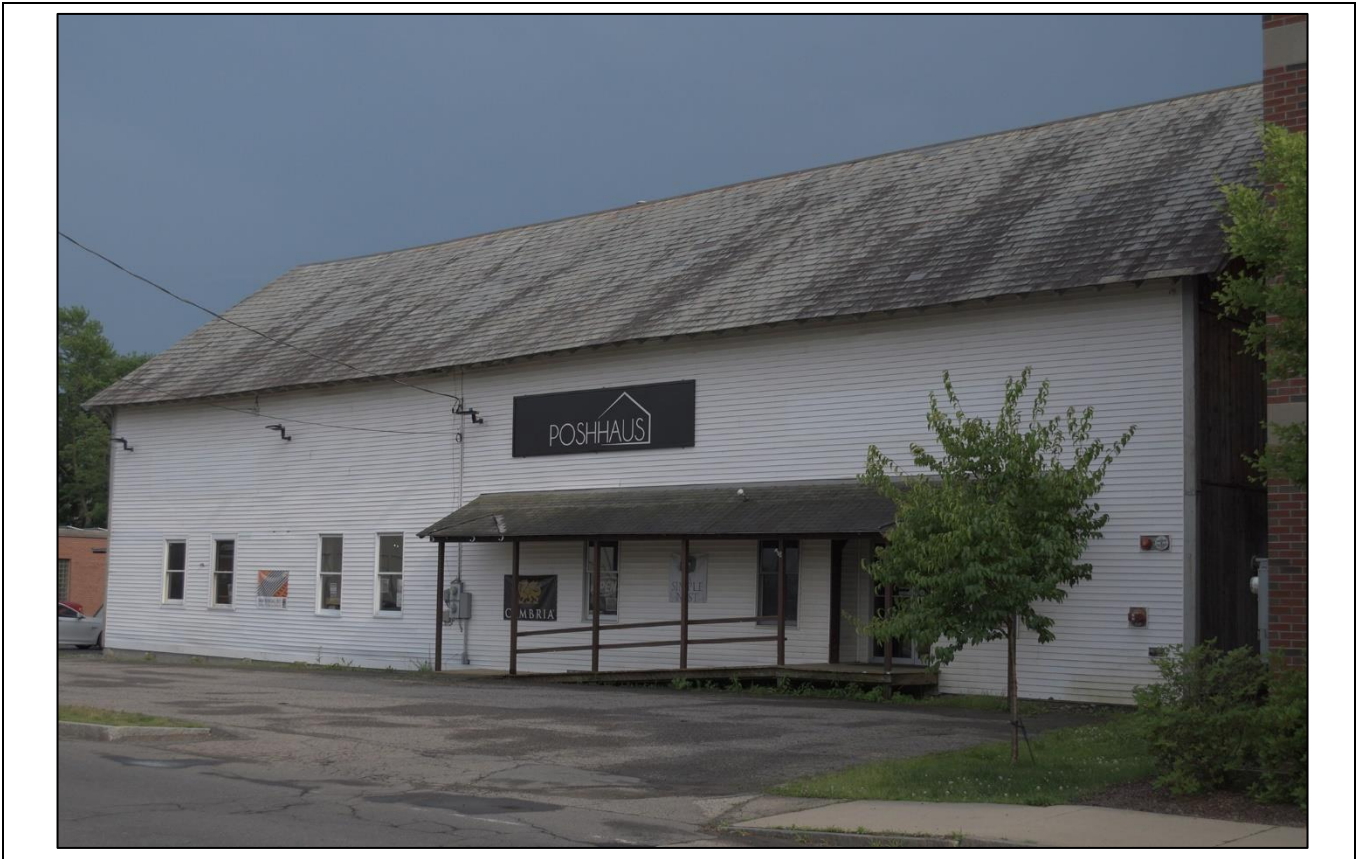
<b>Photo No. 3</b>	104 Emerald-2024-3.jpg	<b>Date</b>	June 19, 2024	<b>Direction</b>	Southeast
<b>Notes</b>	Another view of the north (primary) elevation of the former Dunn & Salisbury lumber storage building.

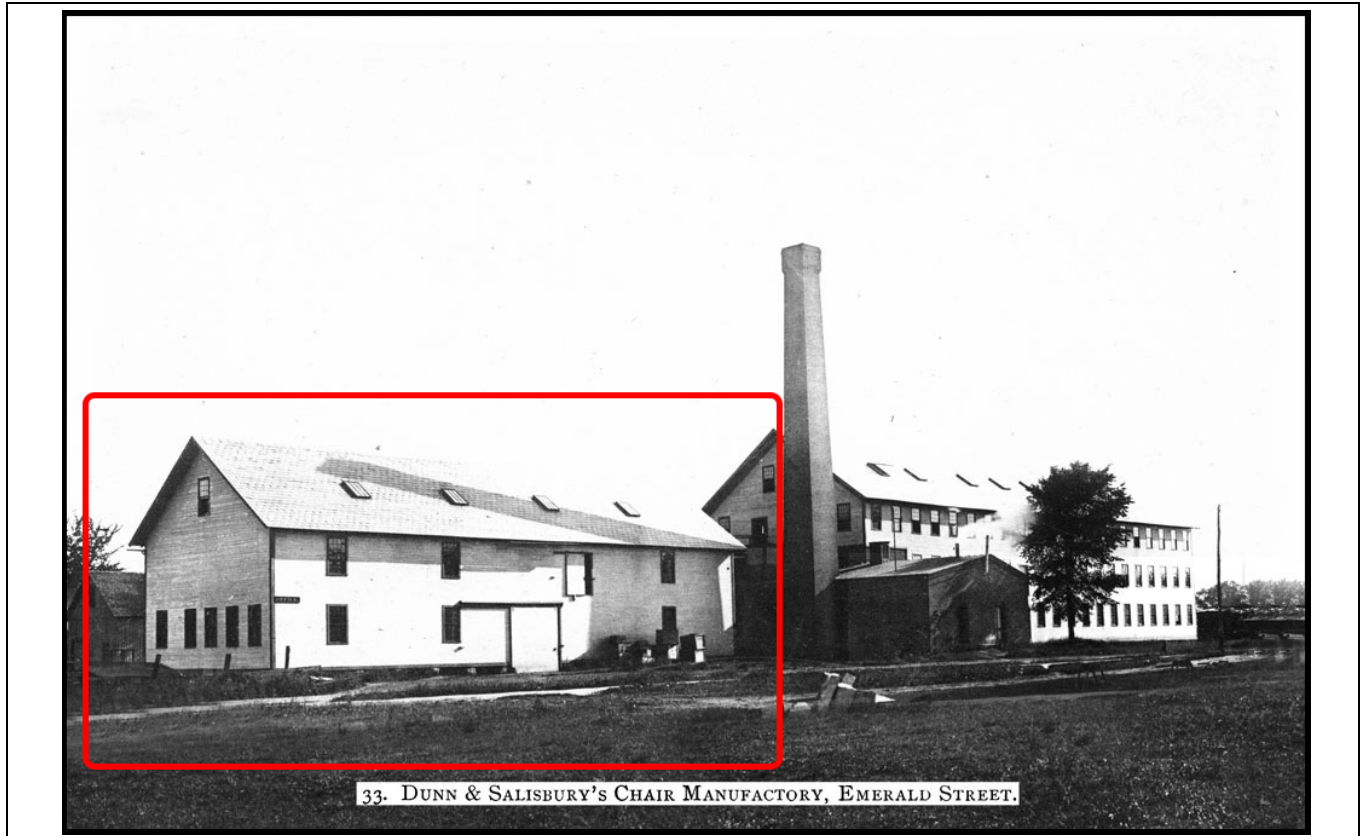
<b>Historic Photo 1</b>	<b>Dunn &amp; Salisbury's Chair Manufactory</b>	<b>Direction</b>	Southwest
<b>Notes</b>	The Dunn & Salisbury Chair Factory was originally constructed in ca. 1887 as a large connected wood-framed building at the corner of Emerald and Ralston Streets with a high brick chimney and attached gable-front brick engine room. Sometime between the 1892 Hurd Map and the 1902 Sanborn Fire Insurance Map, the large wood-framed warehouse (now 104 Emerald Street) was constructed (Photo Courtesy Keene Public Library).

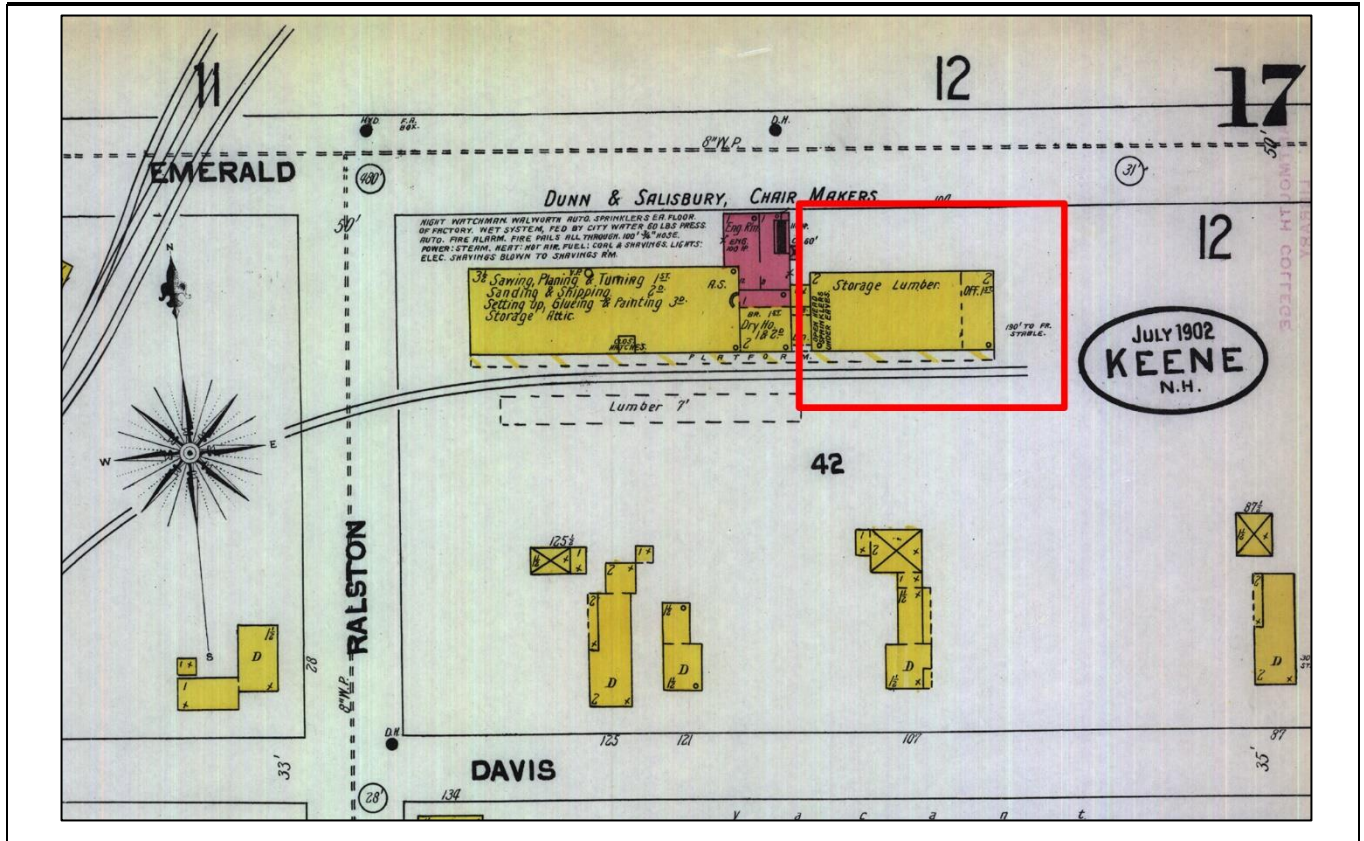
<b>Historic Photo 1</b>	<b>1902 Sanborn Fire Insurance Map, Sheet 17</b>	<b>Direction</b>	N/A
<b>Notes</b>	The site now occupied by 104 Emerald Street housed the lumber storage and offices of the Dunn & Salisbury Chair factory in July 1902 (Dartmouth College Digital Collections). A modern storage building, by this time the two-story structure was fitted with sprinklers under the eaves.

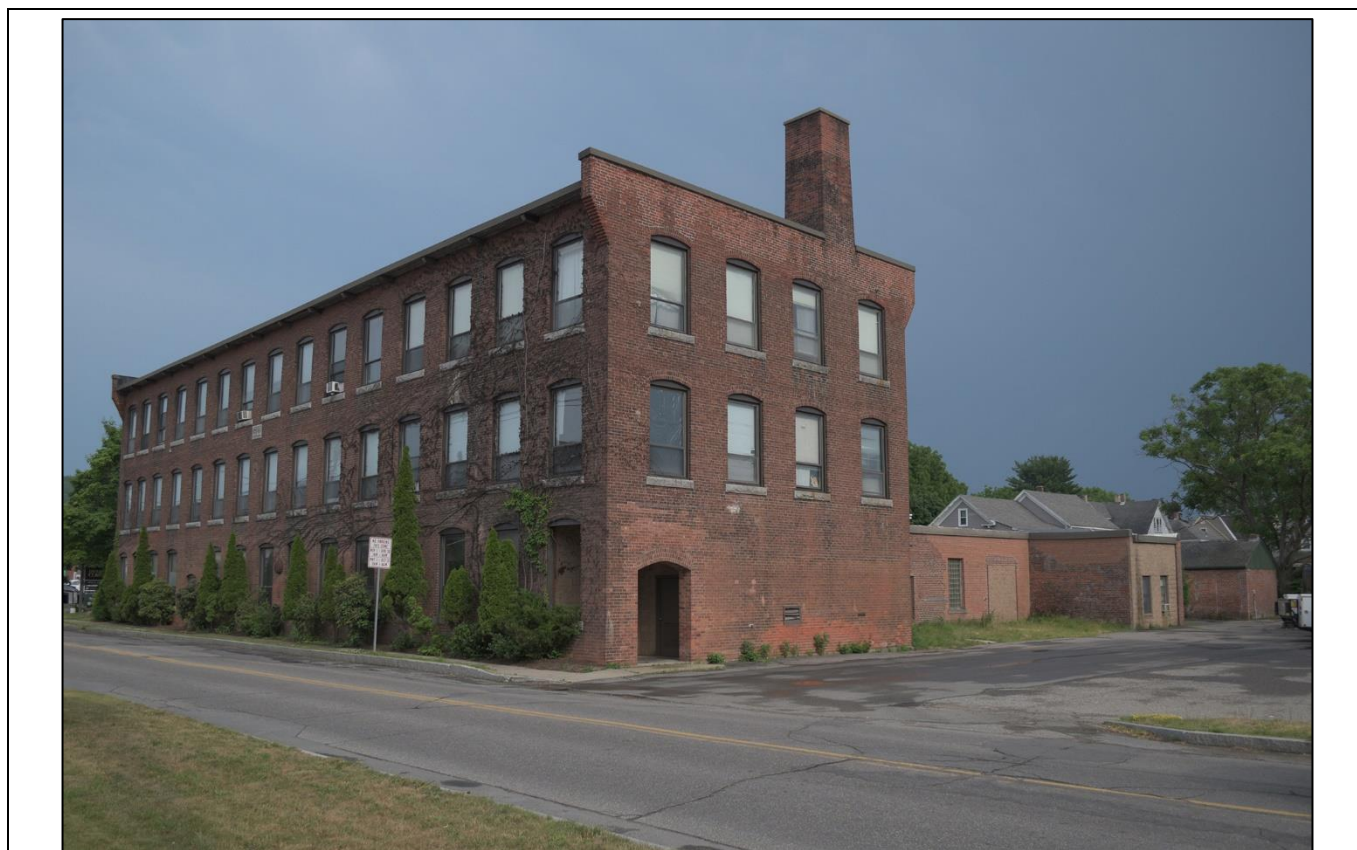
<b>Photo No. 1</b>	80 Emerald St-2024.1.jpg	<b>Date</b>	June 19, 2024	<b>Direction</b>	Southeast
<b>Notes</b>	<p>North and west elevations of former Rawson Turning Factory building. Note the evenly-spaced large windows to provide natural lighting to the interior of the factory building. The exterior architectural ornamentation is minimal (note eave ornamentation and rusticated granite window sills) as is typical of an industrial building of the early 20<sup>th</sup> century</p>

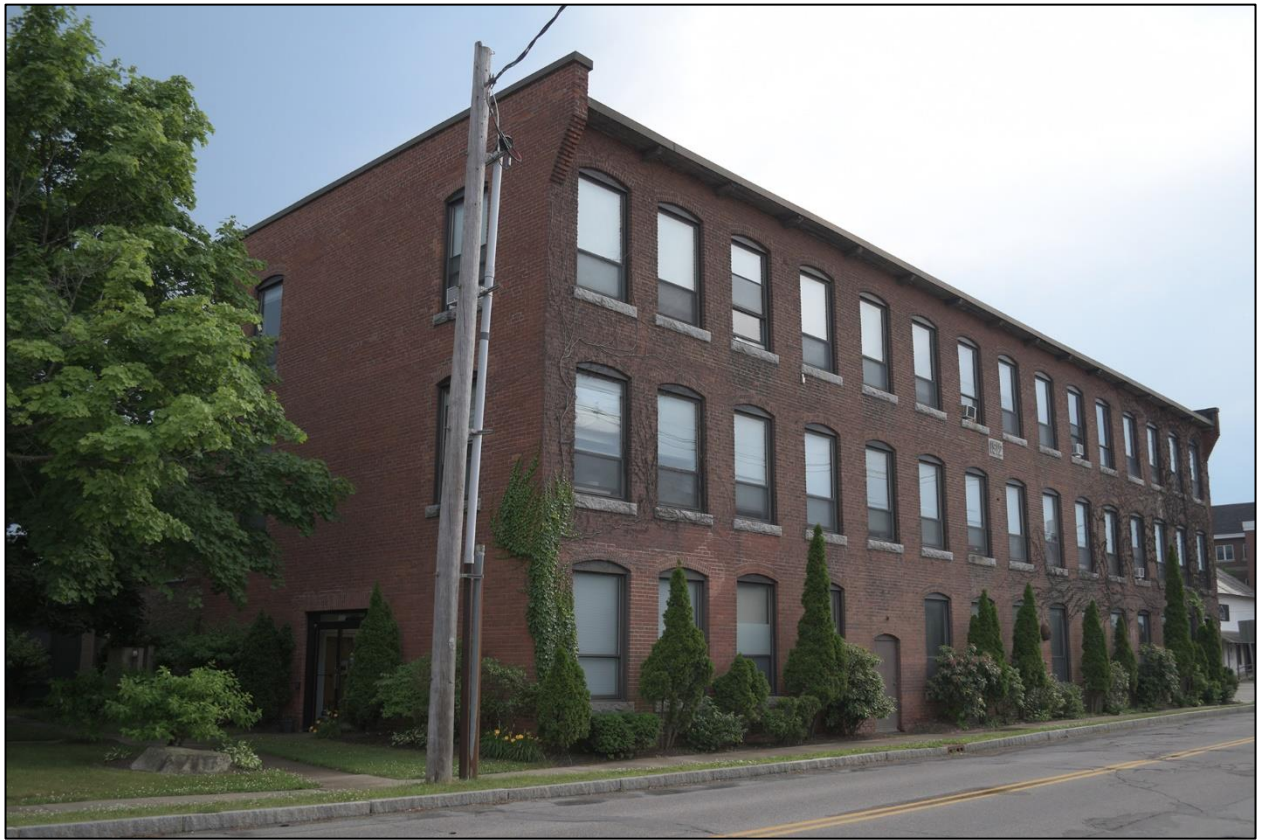
<b>Photo No. 2</b>	80 Emerald St-2024-2.jpg	<b>Date</b>	June 19, 2024	<b>Direction</b>	Southeast
<b>Notes</b>	Note evenly-spaced large windows to allow natural light into interior of factory building combined with simple architectural details befitting a utilitarian early 20 <sup>th</sup> century structure .

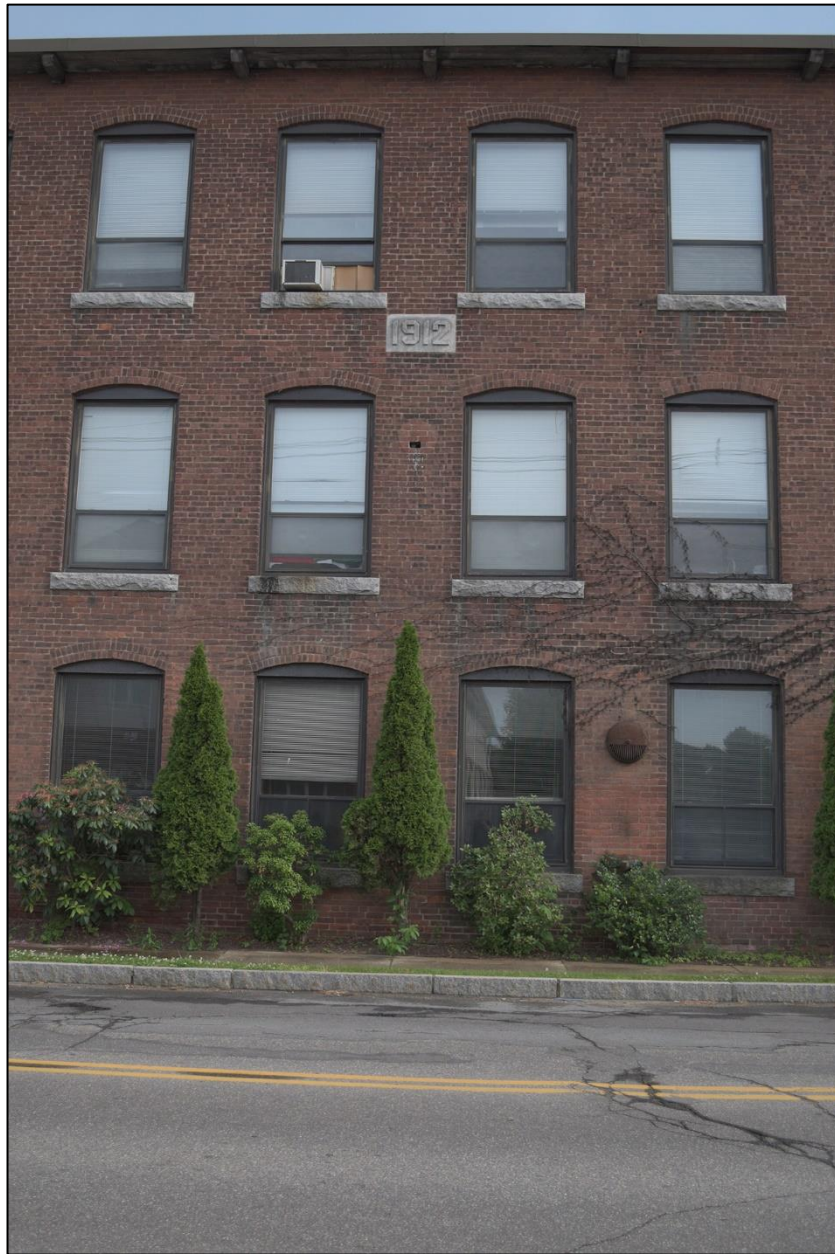
<b>Photo No. 3</b>	80 Emerald St-2024-3.jpg	<b>Date</b>	June 19, 2024	<b>Direction</b>	South
<b>Notes</b>	Detailed photograph of the north elevation (primary façade) of the Rawson building showing the carved granite block with the date “1912” at the center of the façade. Note the rusticated stone window sills and exposed rafter-tails at the open eaves of the building as well as the historic cast-iron ventilation cover between the first-floor windows.

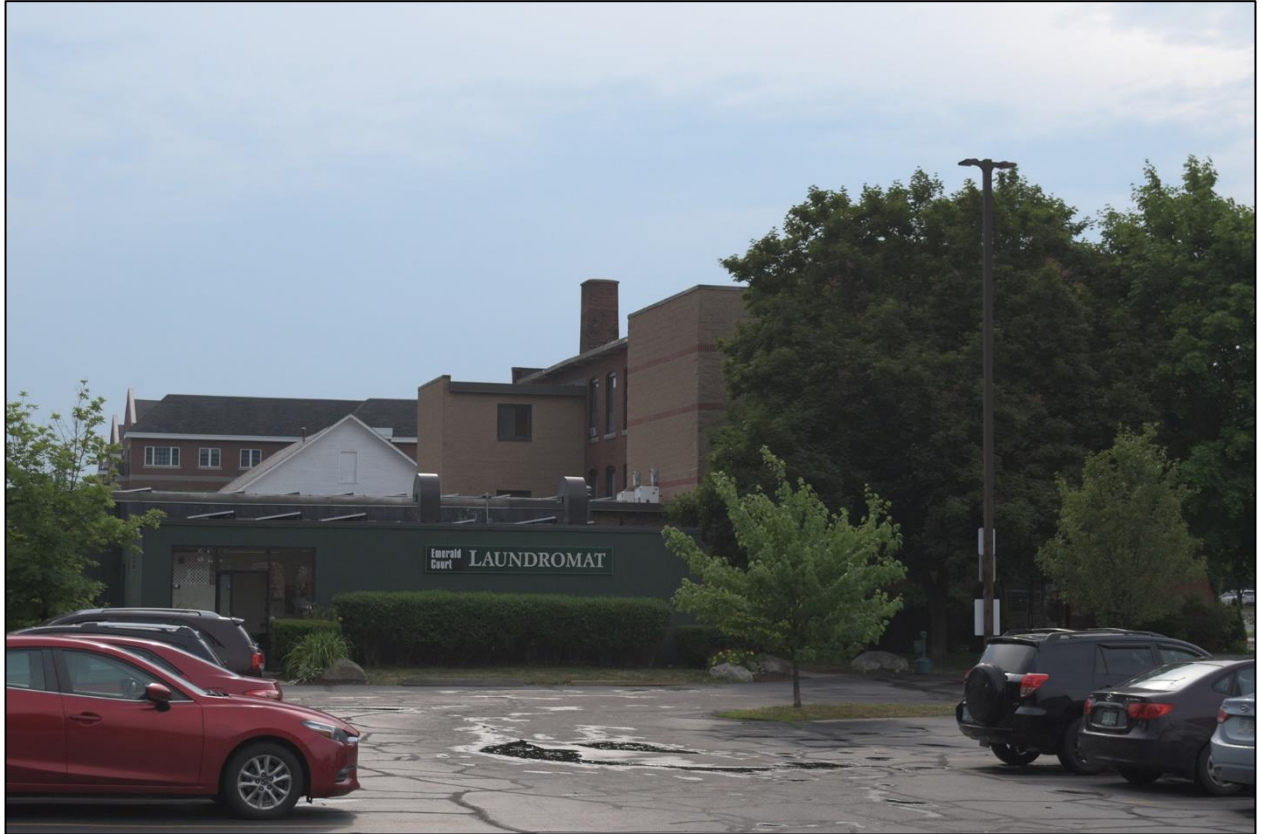
<b>Photo No. 4</b>	80 Emerald St-2024-4.jpg	<b>Date</b>	June 19, 2024	<b>Direction</b>	East
<b>Notes</b>	View of ca. 1920 single-story brick addition behind modern laundromat addition from across parking area.

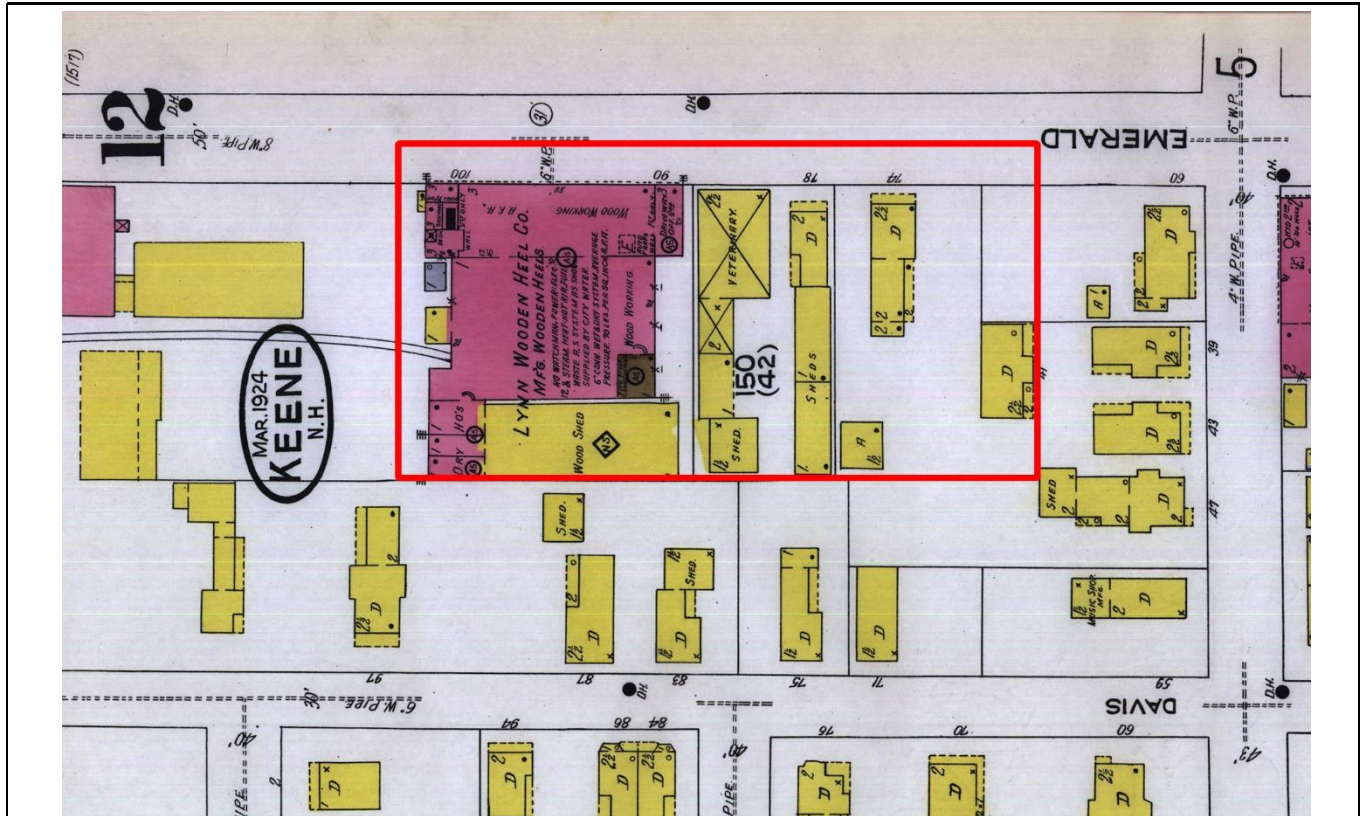
Historic Photo 2	March 1924 Sanborn Fire Insurance Map, Sheet 12	Direction	N/A
Notes	<p>By 1924, a large single-story brick addition was constructed off of the rear elevation of the original Rawson building to connect to the formerly free-standing lumber storage building. By this time, the building housed the <b>Lynn Wooden Heel Co.</b>, a manufacturer of wooden shoe heels for ladies' shoes. In 1935, the building was purchased by Colley B. and Eli Court and run as the <b>Keene Wood Heel Co.</b> through the 1960s while Lynn Heel Co. relocated to Railroad Street.</p>

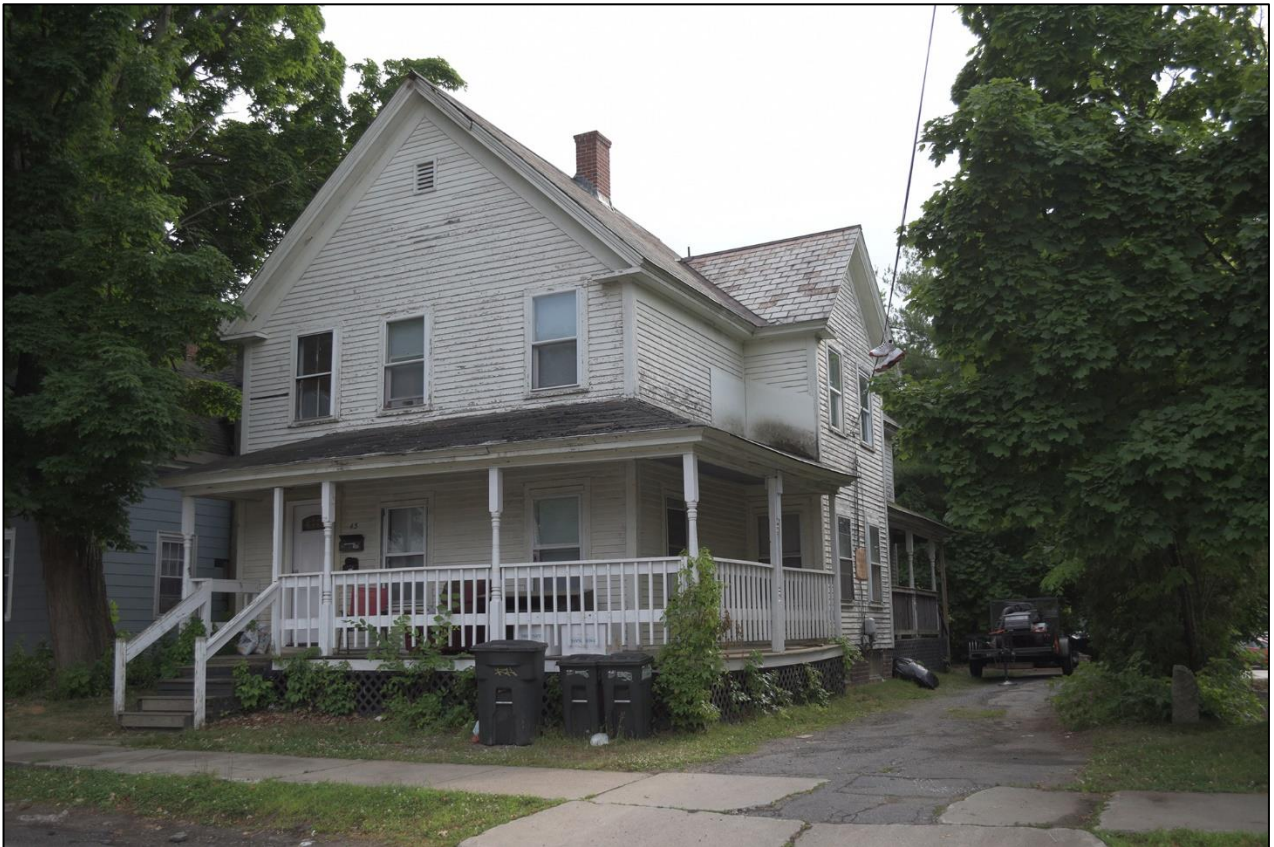
<b>Photo No. 1</b>	43 Wilson St-2024-1.jpg	<b>Date</b>	June 19, 2024	<b>Direction</b>	Southwest
<b>Notes</b>	The former Gates house retains character-defining historic features such as general form and massing, historic slate roof, historic wooden clapboard siding, fenestration (door and window) locations, historic brick chimney, turned porch columns and plug-split granite posts at the corners of the lot. All of these features are fairly typical for a middle-class suburban home of the late 19 <sup>th</sup> century.
