# Wetland Functional Assessment

WETLAND AREA 1  
G2 HOLDINGS, LLC  
Map 215, Lot 7  
KEENE, NH

### Wetland Area 1: G2 Holdings - Keene, NH

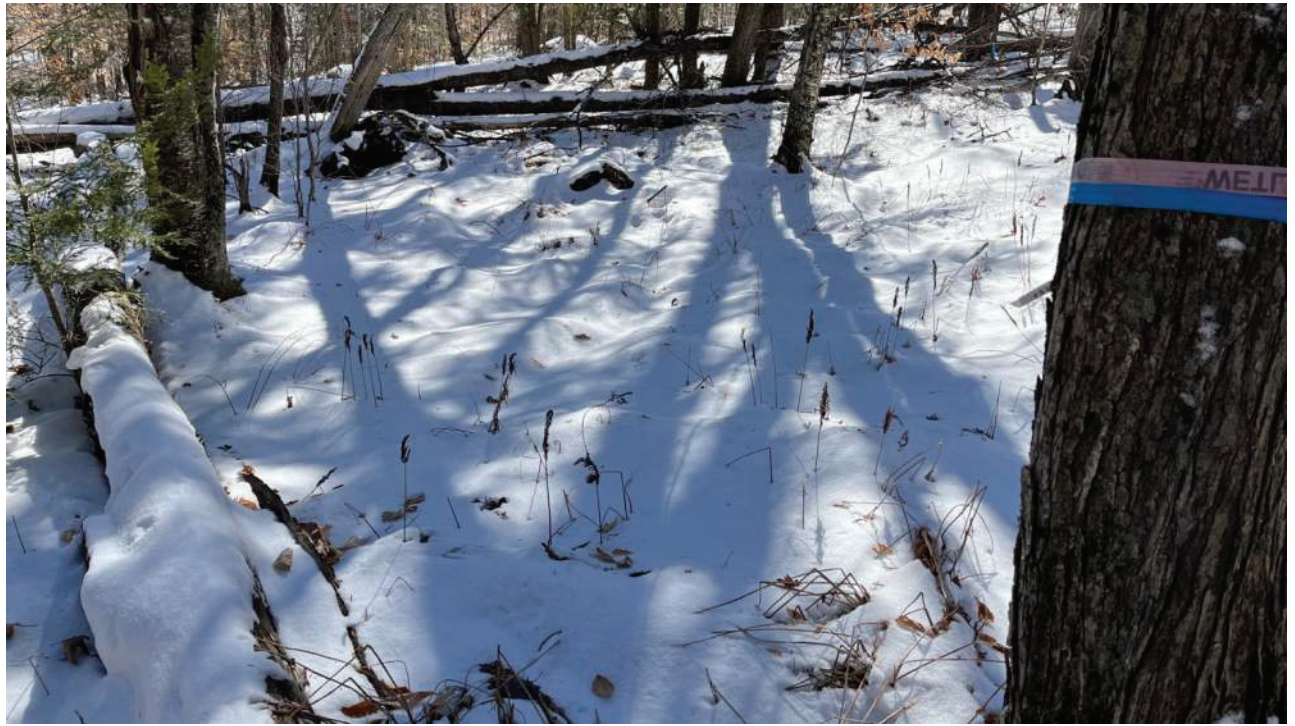
**Location:** Wetland Area 1, southern section

**Description:** Forest canopy: Red Maple and Hemlock, with Sensitive Fern herbaceous layer.

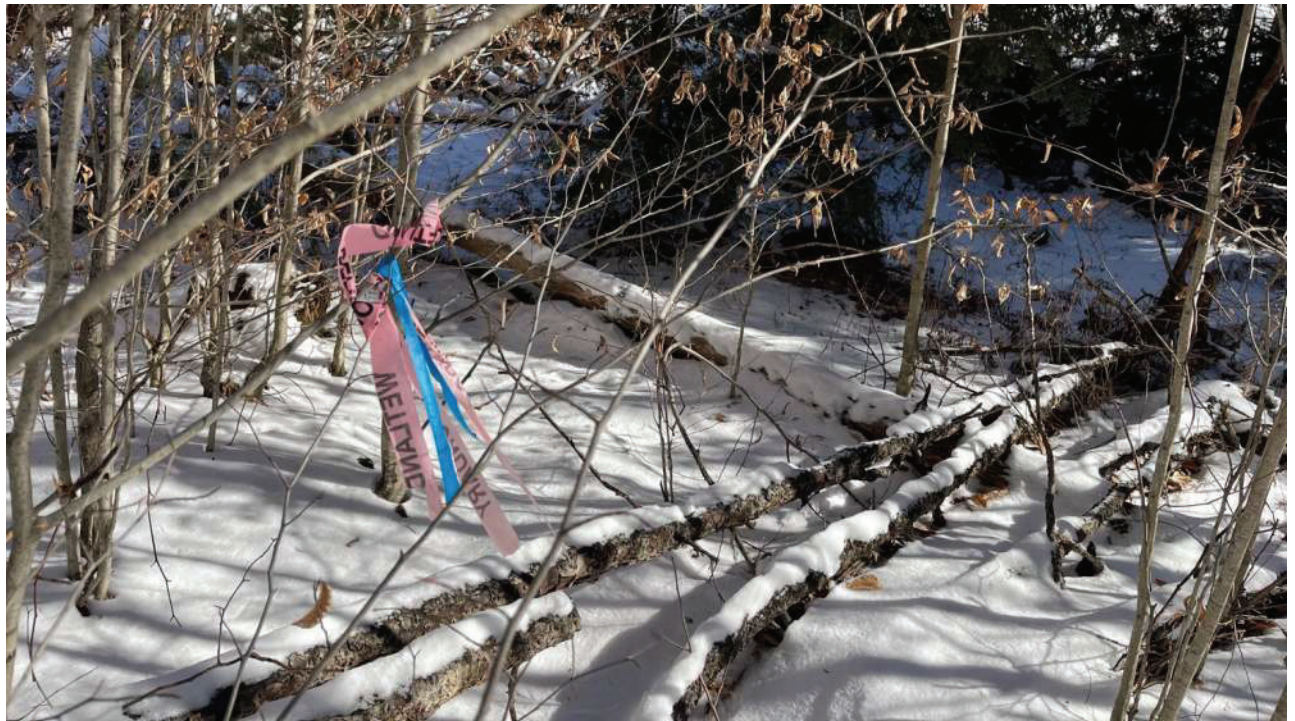
**Location:** Wetland Area 1, at elevation 860'

**Description:** Beech tree saplings in valley bottom indicates minimal saturation, for a wetland.

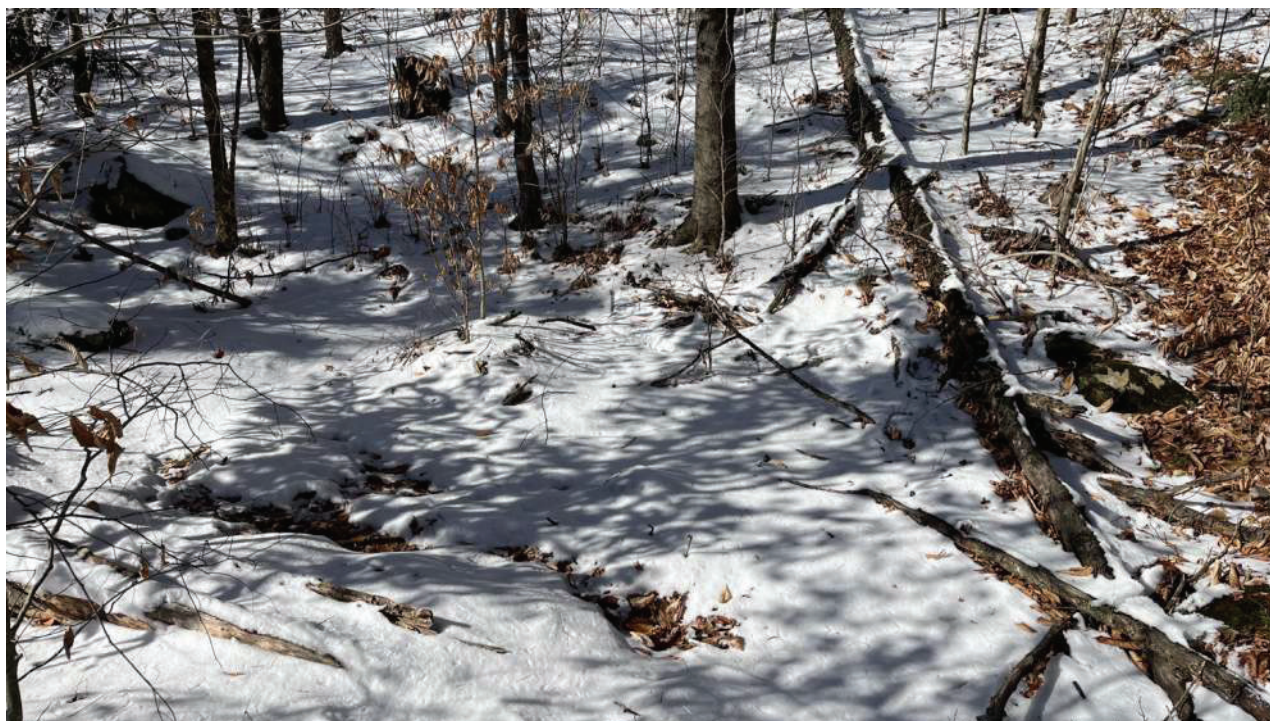
**Location:** Wetland Area 1, at elevation 875'

**Description:** Snowmelt here is evidence of a longer saturation period here. Leaf litter indicates little or no surface water flow in this section.

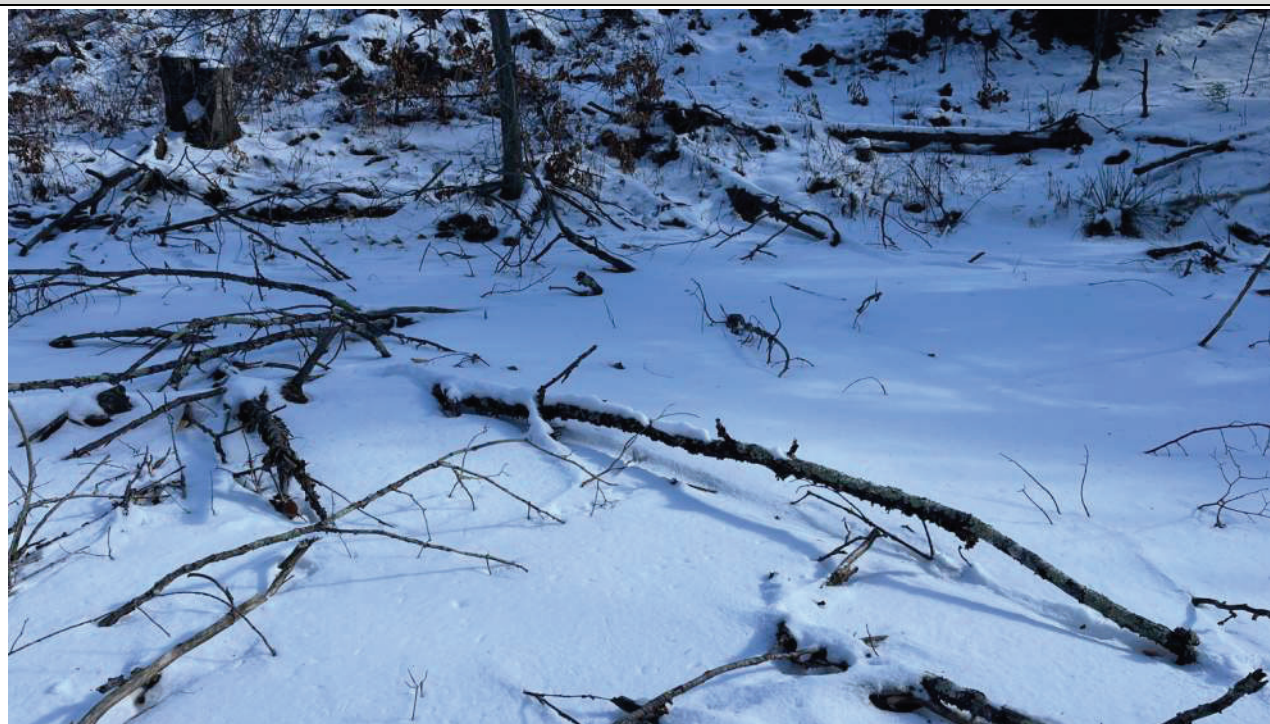
**Location:** Wetland Area 1, at elevation 884'

**Description:** Minimal ponding is evident from the shallow ice crust on the surface. Note: this area was dry in July. Likely not to be wet enough, or deep enough to support amphibian breeding and development.
