# **EXHIBIT 10**

**CITY OF KEENE, NH**  
BEAVER BROOK HABITAT ASSESSMENT  
BANK EROSION HAZARD INDEX (BEHI) EXHIBIT SHEET 1

CITY OF KEENE, NH  
BEAVER BROOK HABITAT ASSESSMENT  
BANK EROSION HAZARD INDEX (BEHI) EXHIBIT SHEET 2

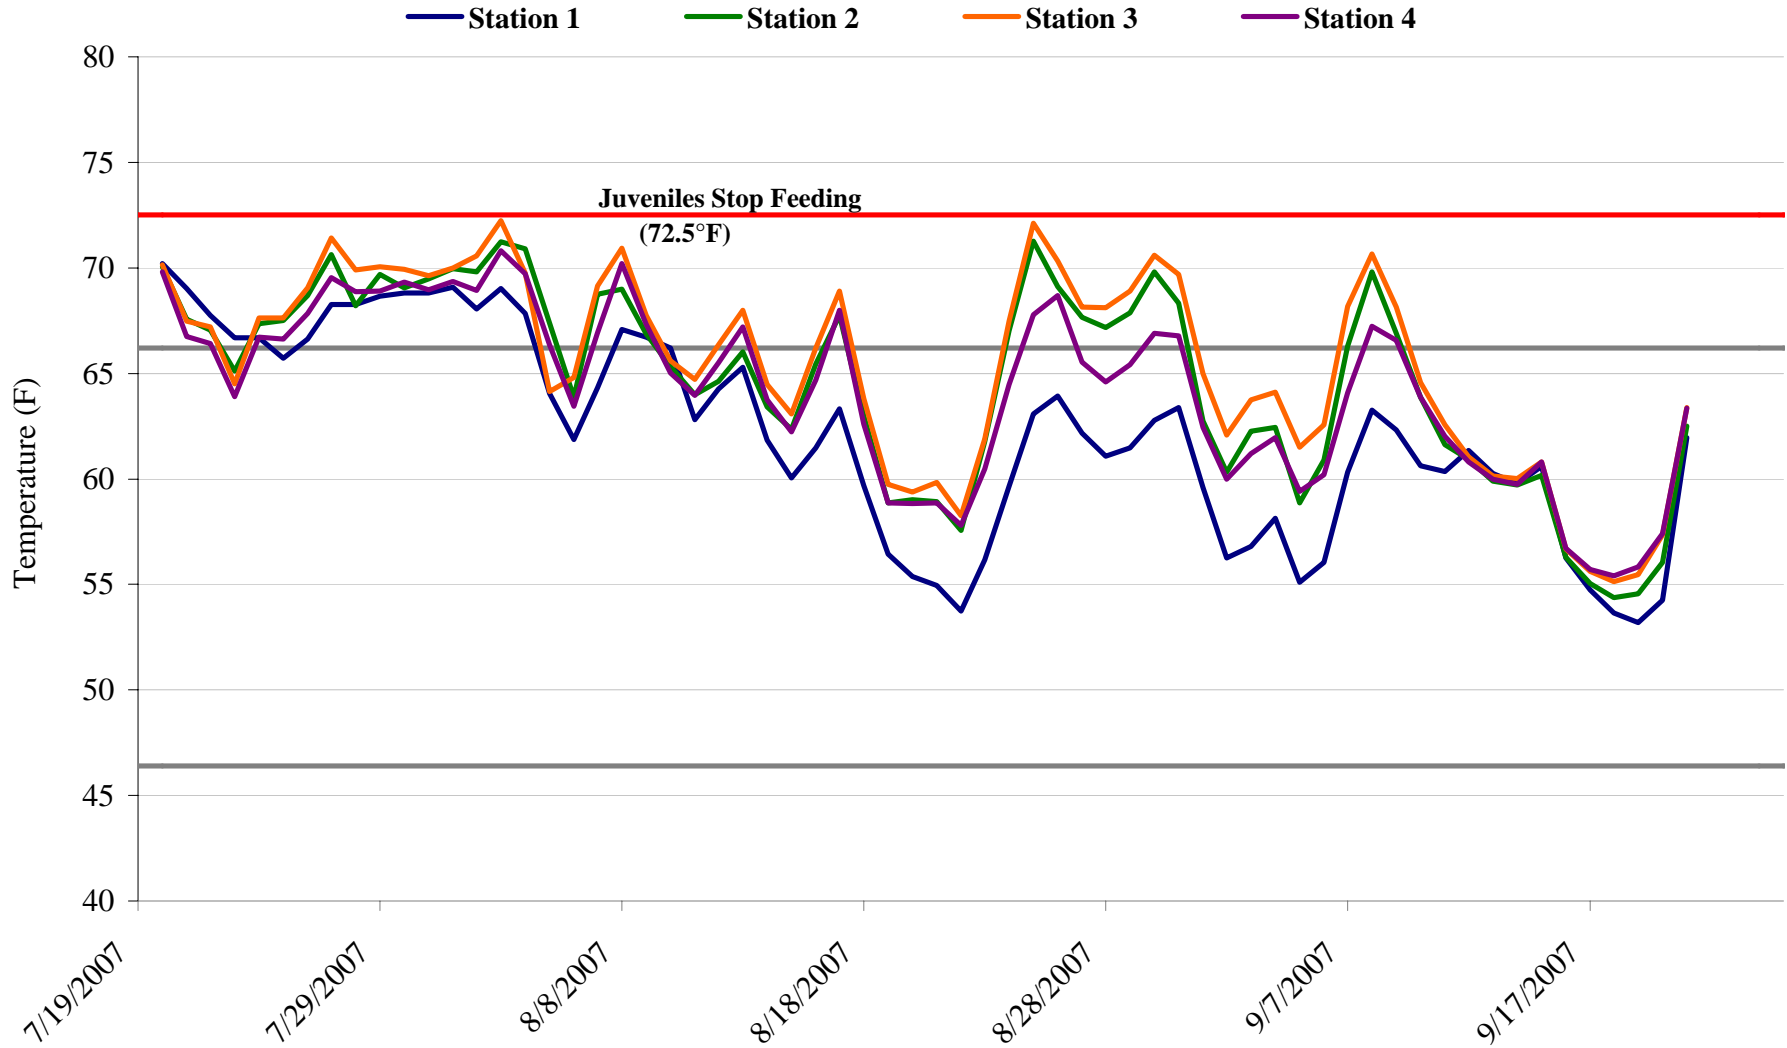
# Beaver Brook Daily Average Temperatures plotted against Juvenile Atlantic Salmon Temperature Requirements

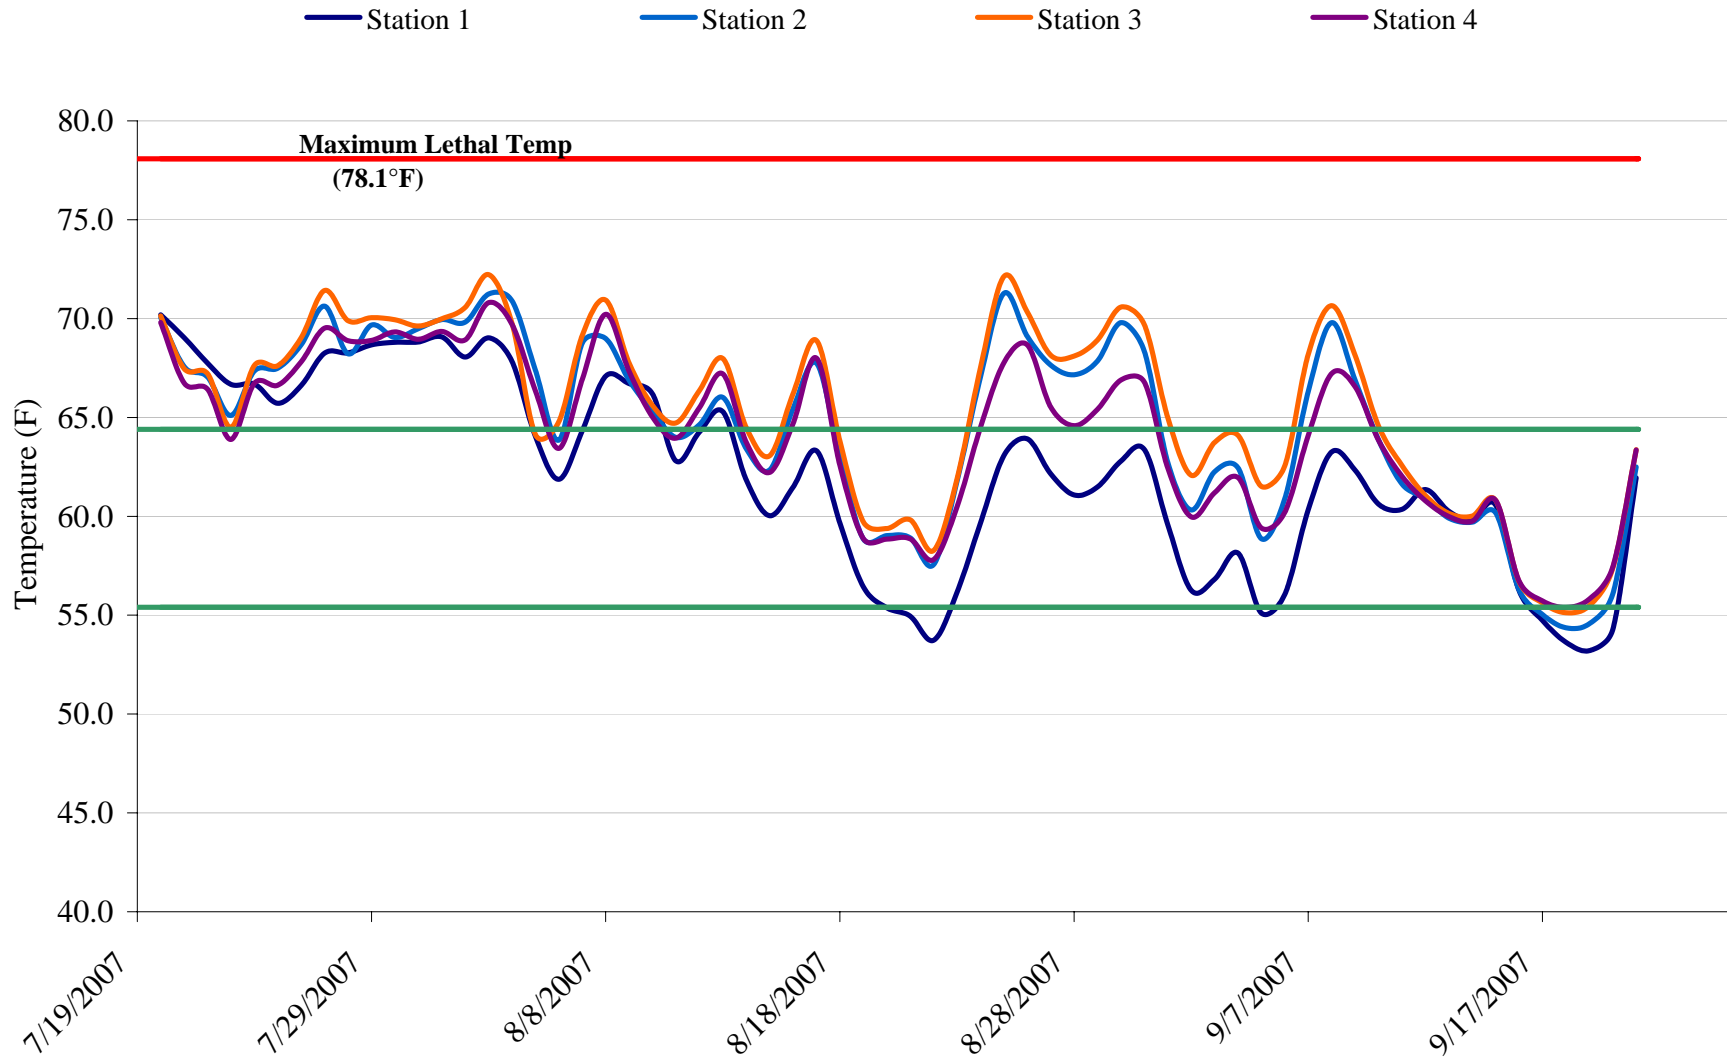
# Beaver Brook Daily Average Temperatures plotted against Brook Trout Temperature Tolerances
